Investigation of the conservation-treatment methods of the Dutch national monument: the role of microscopy

TNO Building and Construction Research, Division of Building Technology
P.O. Box 49, NL-2600 AA Delft, The Netherlands

The Dutch National Monument in Amsterdam, a World War-II memorial structure, was built with an outer face consisting of slabs of travertine. In 1995, the masonry structure forming the core of the monument showed severe deterioration. In order to determine the actual cause of deterioration and to advise on the most suitable method of restoration, an extensive investigation was carried out on the monument itself and on samples removed from it. The action of frost was found to be the primary cause of the deterioration to the brick structure. The travertine slabs and sculpture showed decay in the form of cracks and of smoothening of the sculptural details (superficial loss of material). For purposes of restoration, the monument was completely dismantled and the inner masonry structure was replaced with prefabricated concrete. The sculptures (statues and reliefs) were treated with a special acrylic resin (polymethyl metha-acrylate, PMMA) in order to conserve them

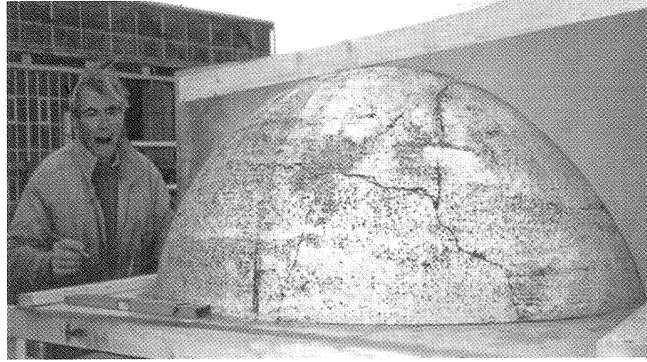
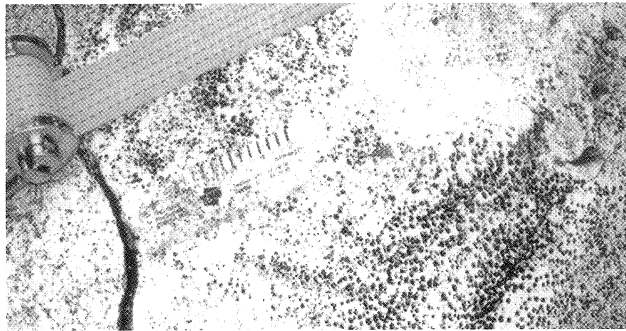
Fig. 2. Cover stone of the central pylon of the monument showing wide cracks (a) overview; (b) details.

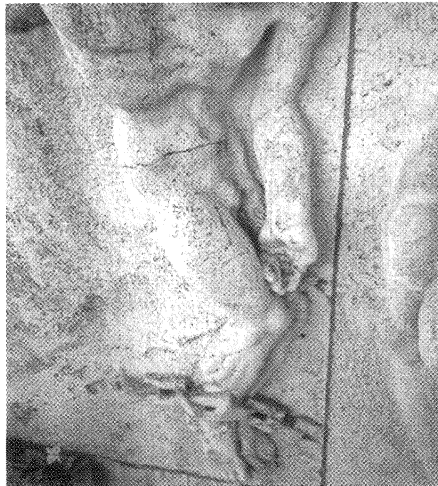
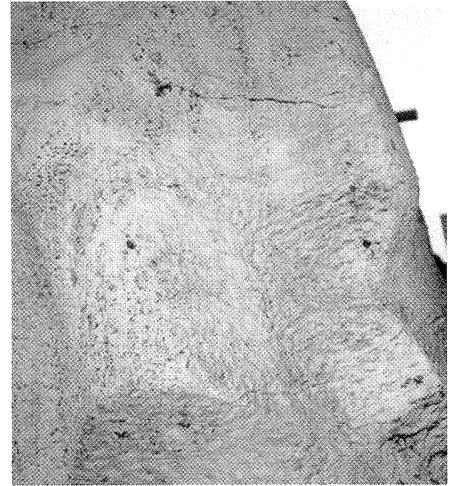
Fig. 3. Part of the statues at the front side of the pylon showing cracks. (a) overview; (b) details.

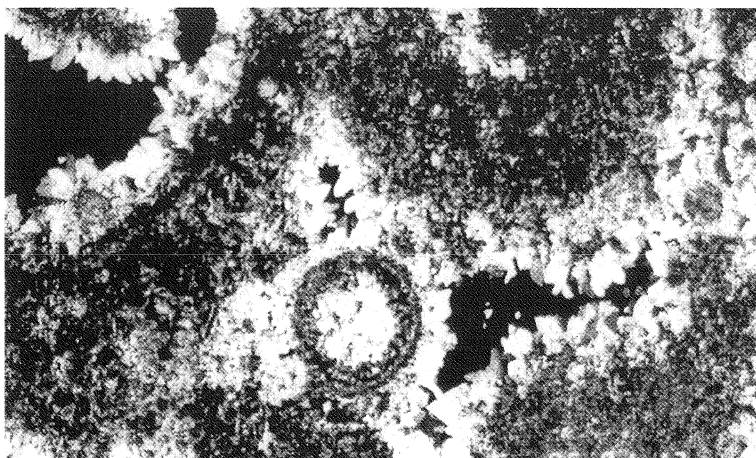
Results of the investigation showed that the travertine stone was composed of fine-grained calcite (micro- to cryptocrystalline calcite - *micrite aggregates*), alternating with fossil concretions, cracks and microfissures with different sizes (see Figure 4). Various “voids” were identified including “visible” pores and capillary pores. The visible pores are those voids that could be seen in the thin sections. In the case of the capillary pores, the sizes are so small (sizes 0.01–1 μ m), that the individual pores are not distinguishable with a normal optical microscope even with the highest magnification of about 400 times.

Fig. 4. PLM-micrograph (transmitted light) of an overview of the affected travertine stone showing re-crystallisation of calcium carbonate in large voids.
Size of micrograph is 2.7 mm \times 1.8 mm.

The visible voids were found to be intrinsic in origin and “closed” (not connected with each other). The sizes of these voids ranged between 0.1 and 3 mm. At various places within the stone, re-crystallisation of calcite had resulted in the formation of smaller visible voids, ranging in size between 0.1 and 1 mm. The zones with micrite aggregates were found to be ‘denser’ (lower

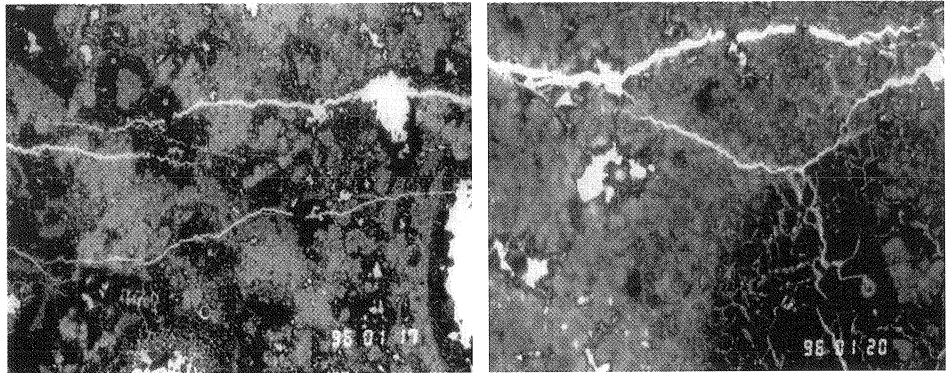
Deterioration was mainly physical, caused essentially by frost. This was limited to a depth of 25–30 mm from the exposed surface of the stone. This frost-initiated physical deterioration was manifested by some minor superficial flaking and by the formation of cracks parallel to the exposed surface of the travertine stone (see Figure 5).

Fig. 5. PFM-micrograph (fluorescent light) of the cover stone showing very fine cracks parallel to the surface of the stone. Size of micrograph is 5.4 mm \times 3.5 mm.

Most of the frost-initiated cracks measured in length up to about 2 or 3 centimetres and varied in width from about $10 \mu\text{m}$ up to about $50 \mu\text{m}$. In addition, there was locally superficial loss of material (estimated to be about 1–2 mm) caused by scaling. The deterioration was considerably influenced by the intrinsic characteristics of the travertine. The presence of zones of dense and highly fissured material, alternating with relatively porous and permeable material enhanced the frost action. Chemical deterioration of the stone, usually caused by either conversion of the carbonate rock by sulphate to gypsum or dissolution by the relatively (acidic) rainwater was negligible. The results of the PFM investigation confirmed the results of the visual inspection and the physical tests (freeze-thaw and water absorption under vacuum), all of which pointed to frost as the primary cause of weathering but not chemical deterioration.

The results of the PFM studies provided a basis for selecting the most suitable method for conservation of the stone, namely by impregnation with a suitable agent in order to seal-off the cracks and voids.

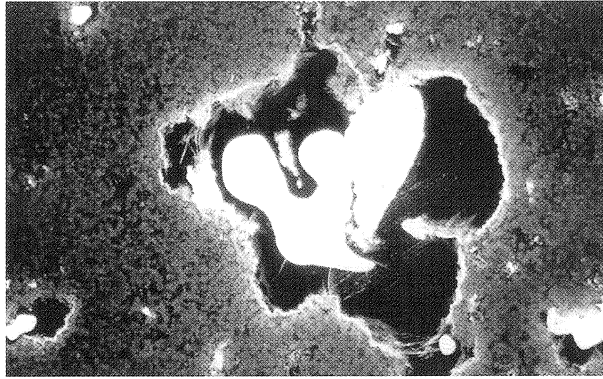
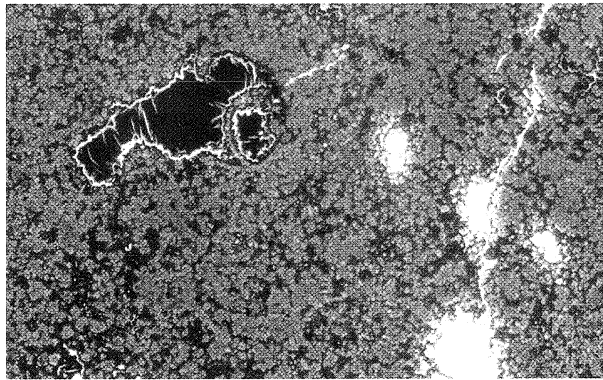
Aspects	Injection method	
	PMMA	Water glass
Extent of voids filled, % (V/V)	40-50	≤ 40
Nature of filling	Mostly along periphery of Voids, central portion Unfilled (see Figure 6)	Mostly along periphery of voids, central portion, mostly unfilled (see Figure 7)
Shrinkage of injected material	Considerable shrinkage showing de-bonding from crack and pore void walls	Extensive shrinkage especially along the walls of the voids
Filling of cracks and fissures	Partial filling of cracks and fissures	No
Filling distribution over the sample	Good, everywhere the same: 40–50 % filling of voids	Poor, varied from 5 % filling of voids locally and in one thin section, up to 30 or 40 %
Contact of the injected material with the walls of the voids	Moderate	Good

Fig. 6. PFM-micrograph of one of the laboratory-treated samples showing voids (visible pores and cracks) filled by PMMA and the associated fine shrinkage cracks along the walls of the voids. Size of micrograph is 2.7 mm \times 1.8 mm.

The shortcomings of the PMMA method were discussed with IBACH, the company that carried out the impregnation (the applicator). On the basis of the opinion of experts from IBACH, a too short drying period was thought to be the explanation for the shortcomings. Therefore it was proposed to use a longer drying period for the sculptures.

On the basis of the results of the investigation, in combination with the results of other tests, such as a frost resistance test, the method of impregnation using PMMA was considered to be the better option and as such selected as the conservation treatment method for the sculptures.

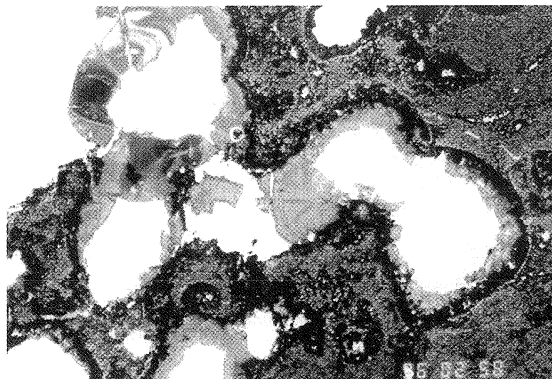
Fig. 7. PFM-micrograph of one of the samples laboratory-treated samples showing visible voids filled by the water glass associated with shrinkage. Size of micrograph is 5.4 mm \times 3.5 mm.

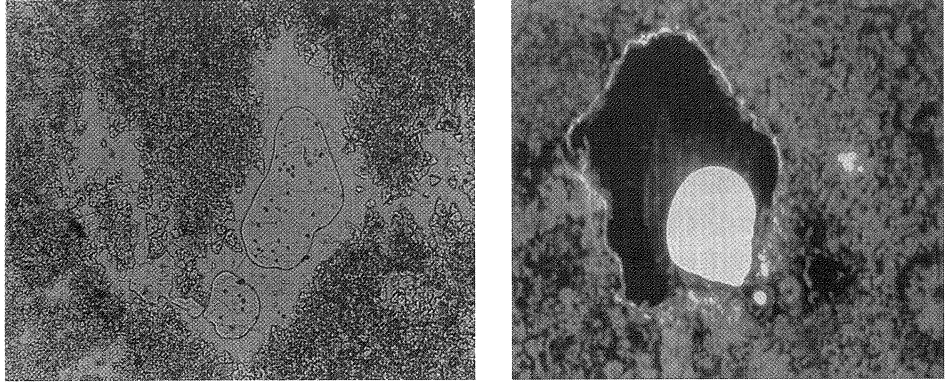
Most of the visible voids were filled with PMMA. In some cases, shrinkage of the acrylic resin was visible in the form of “hollow spaces” within the PMMA-filled voids or as very fine cracks ($< 5 \mu\text{m}$) locally along the walls of the voids (see Figure 8). The extent of shrinkage was considered not to pose any threat to the conservation of the stone since the extent of filling of larger cracks (widths 0.2 to 0.3 mm) was found to be satisfactory. In the case of the wider cracks, shrinkage cracks along the walls of the voids were not visible (see Figure 9). In general, the results of the treatment of the large reliefs and statues were found to be far better than the results of the pilot study.

Fig. 8. PFM-micrograph of one of the samples taken from statues after treatment with PMMA showing voids by PMMA. Size of micrograph is 2.7 mm \times 1.8 mm.

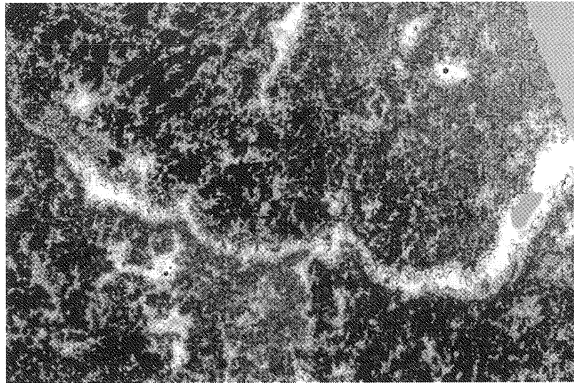
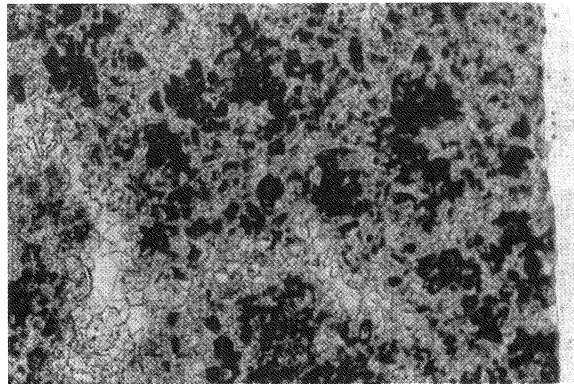
Fig. 9. PFM-micrograph of one of the samples taken from the treated statues showing a long wide cracks filled by by pmma. (a) long, wide cracks; (b) indistinct voids by PMMA. Size of micrograph is 5.4 mm \times 3.5 mm.
