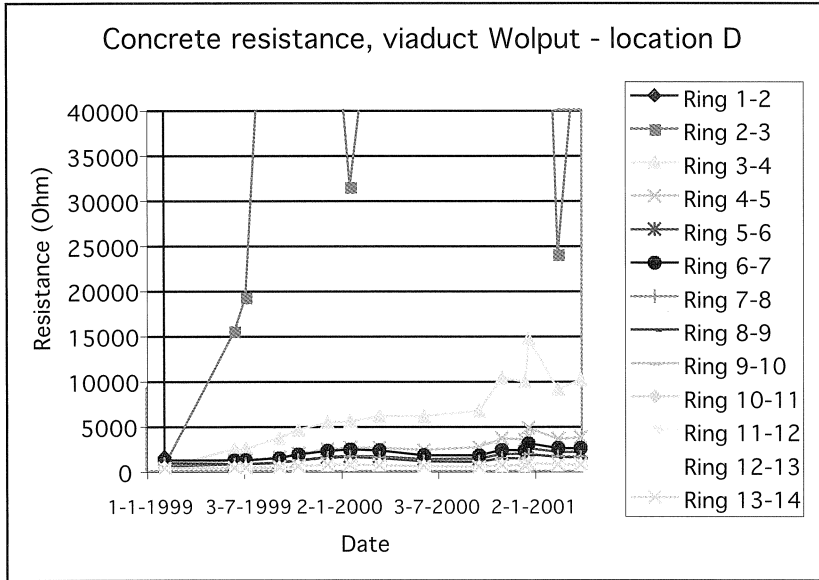
Fig. 5. Concrete resistance at site D, viaduct Wolput.

- For the rings yielding realistic values in viaduct Wolput, those at sites B and D are lowest. Concrete resistances measured at site C are slightly higher, those at A are highest. A lower resistance for concrete of similar composition indicates higher moisture contents, viz. for sites B and D. This is in agreement with field observations.

Visual inspection, concrete resistance measurements using multiple ring sensors and relative humidity measurements indicate the concrete at sites B and D on viaduct Wolput remain humid. Simultaneously, vibrating wire strain gage measurements indicate continuing deformation (expansion) at these sites. This is probably due to continuing ASR expansion. Both sites are situated in the strengthened part of the bridgedeck.

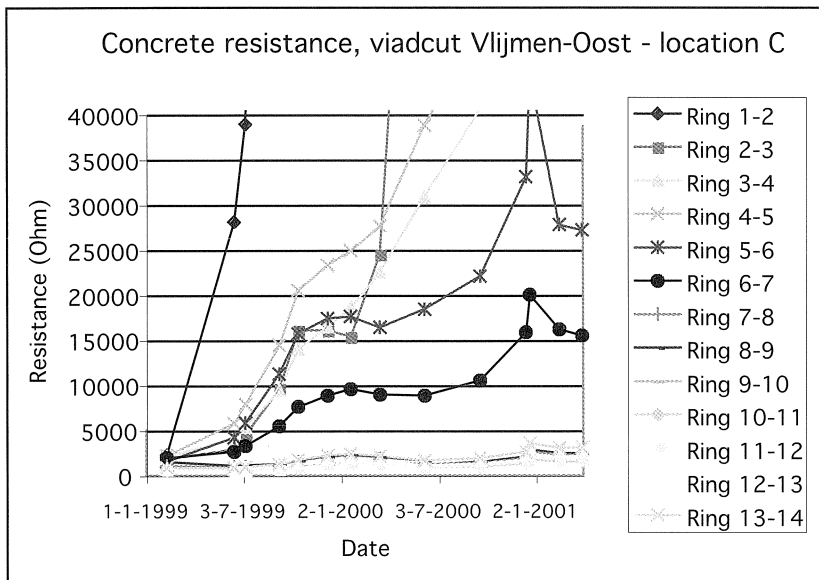
Fig. 6. Concrete resistance at site C, viaduct Vlijmen-Oost.

Rings yielding realistic values in viaduct Vlijmen-Oost show comparable values for concrete resistance at all sites. Resistances are comparable with those at site C in viaduct Wolput. Rings yielding realistic values in both viaducts show an increase in concrete resistance with time in the bottom part of the bridgedecks. This might be explained by some extent of dessication, which is, however, considered unlikely. For most of the timespan during which measurements were performed, both structures had not yet been rehabilitated. Nevertheless, a systematic increase of concrete resistance is measured. The question arises whether this increase should be explained by other processes than dessication.

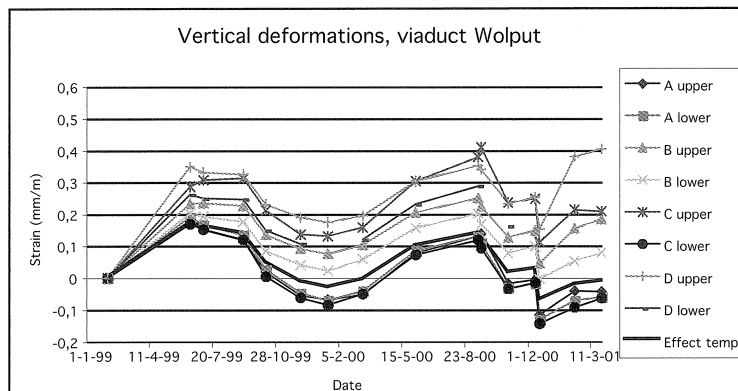
Fig. 7. Vertical deformations in viaduct Wolput, as determined using vibrating wire strain gages. Letters indicate measuring sites, 'lower' and 'upper' indicate the lower and upper sensors at each site, respectively.

It appears that results for all sites in viaduct Vlijmen-Oost and sites A and the lower part of site C in viaduct Wolput agree reasonably well with deformations resulting from variations in temperature. On sites B and the upper part of site C in viaduct Wolput, vertical deformation (expansion) is considerably larger than the temperature effect. This indicates, possible, that expansion due to ASR continues.

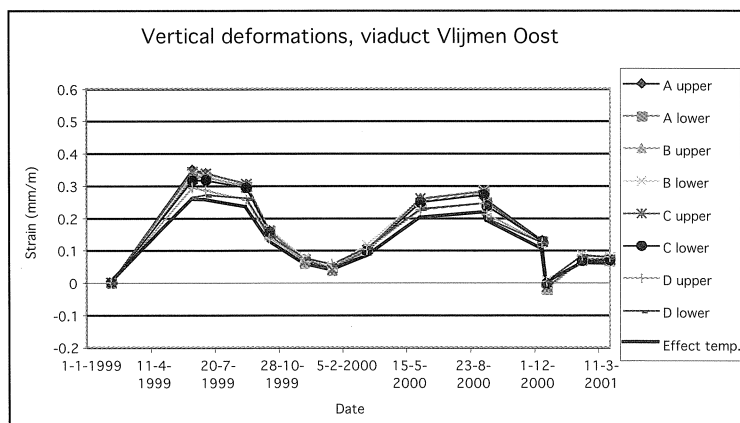
Fig. 8. Vertical deformations in viaduct Vlijmen-Oost, as determined using vibrating wire strain gages. Letters indicate measuring sites, 'lower' and 'upper' indicate the lower and upper sensors at each site, respectively.

Monitoring of relevant variables on viaduct Vlijmen-Oost indicates no deformations other than those derived from varying temperature. The concrete appears to be less humid than that of viaduct Wolput. There are no indications for continuing ASR expansion in the bridgedeck over the measuring period; neither is new development of ASR expected from the measurements, provided that no conditions are changed.

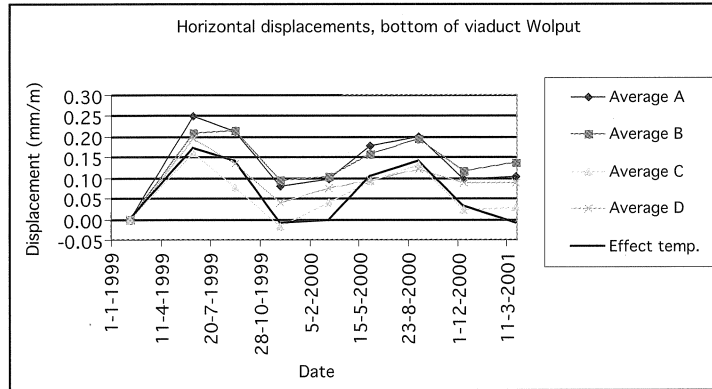
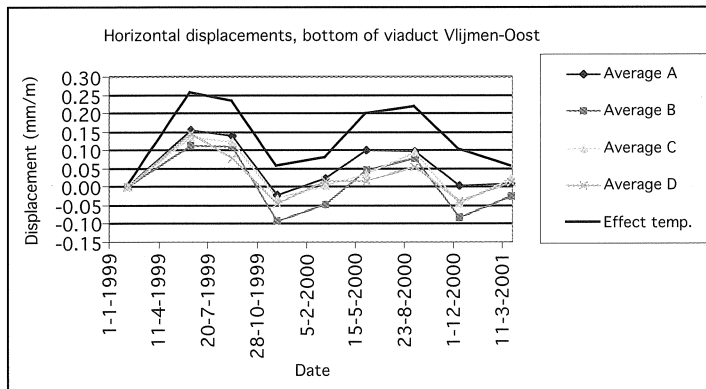
tion due to ASR. Figures 9 and 10 show the average displacements for each direction at each site, as well as the calculated temperature effect.

For all sites, it appears that horizontal displacements agree reasonably well with those expected from measured variations in temperature. No significant differences between different sites have been observed. There are no indications for continuing deformation due to ASR.

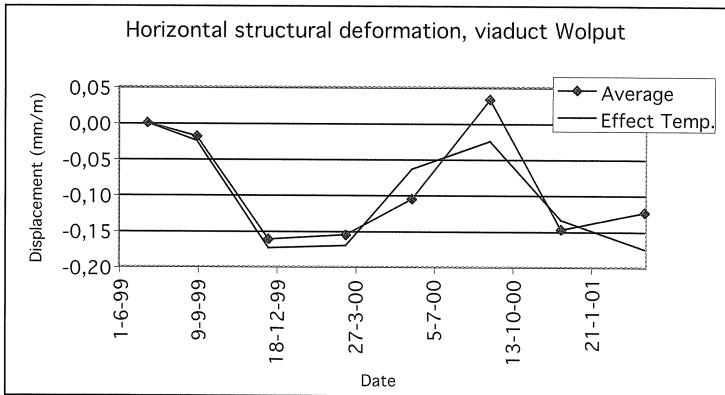
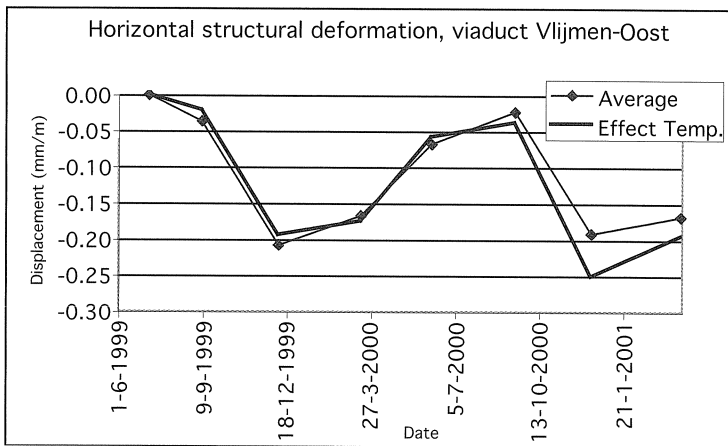
Structural deformations have been measured by determining displacement between successive reference studs on the top of the bridgedecks. Results and the temperature effect are given in figures 11 and 12. The average displacements at all sites correspond with those expected with those calcu-

lated from measured variations in temperature. There are no indications of continuing horizontal structural deformation due to ASR.
