Effect of stylolites on the durability of building stones: two case studies

J.A. Larbi

TNO Building and Construction Research, Delft, The Netherlands

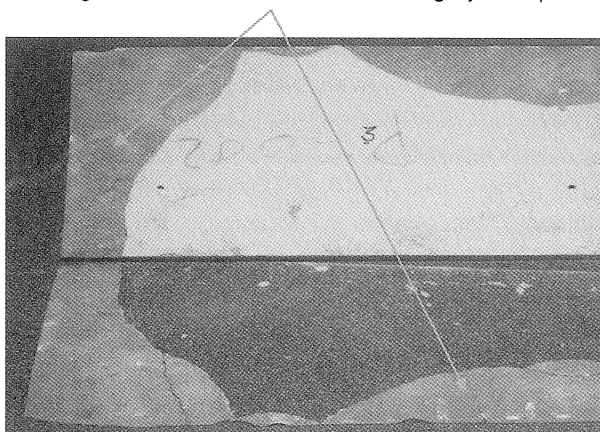
A number of the slabs in the prefabricated concrete elements (at least about 10-20) was found to have partially disintegrated or was in the process of disintegration. The disintegration was almost always in the form of spalling or flaking along the planes of the stylolites in the slabs (Fig. 4).

Damaged features: slabs delaminated along stylolitic planes

Fig. 4. Overview of a sample of the limestone slab in the field showing delamination along inherent stylolitic planes in the slab.

All the disintegrating slabs involved those that contained clay-rich stylolites and the stylolites were also exposed at the polished surface. The sound produced from such slabs from the gentle hammer taps also suggested that they contained loosely bonded layers. This aspect was also applicable to some of the slabs that showed no exposure of stylolites at the polished surface. In most cases, the flakes could easily be removed by means of hitting a chisel gently along the disintegrating stylolitic planes with a hammer.

The main conclusions drawn from the PFM-analysis, the methylene-blue test and the XRD analysis were that the stylolites in the limestone slabs contained, among others, expansive clay minerals, mainly in the form of hectorite, which belongs to the smectite or highly water-sensitive group of clay minerals. The disintegration of the slabs was attributed to a stress-controlled physical delamination of portions of the limestone slabs containing clay-rich stylolites as a result of the alternating wetting and drying of the slabs under the exposed outdoor conditions.

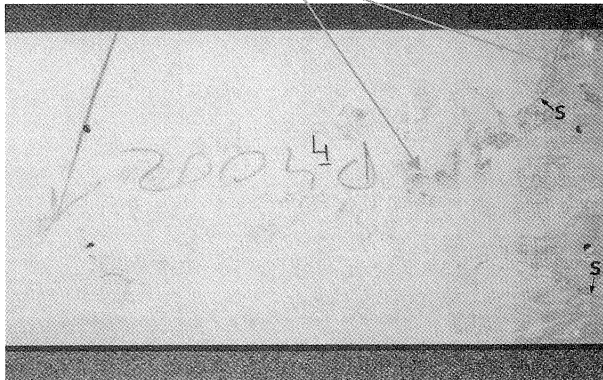
Slab with stylolitic planes

Fig. 5. Overview of a sample of the limestone slab before the autoclave test showing no visible damage. S = stylolite.

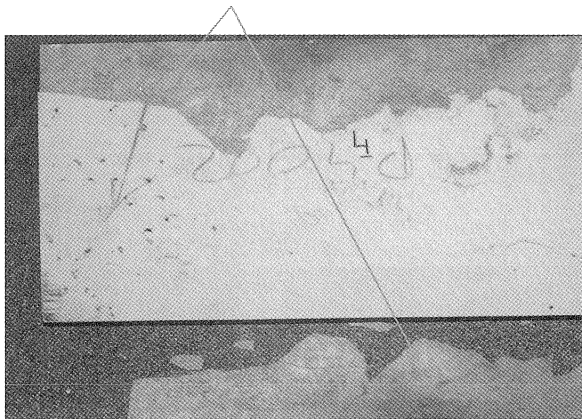
For the damaged slabs, the loosely bonded flakes were easily removed from the respective slabs by means of hitting a chisel with a small hammer along the planes of satellites. Nearly all the forms of disintegration that were observed from the autoclave test were similar to the damage that was observed during the field investigation of the slabs used in the concrete elements. After removing the loosely bonded flakes containing the stylolites, the exposed surfaces of the samples were examined with the aid of a stereomicroscope. Nearly all the examined surfaces were found to contain soft, fine-grained, reddish-brown clayish material, completely different in character from the hard, sound and nearly impermeable limestone portion. Analysis of some of the soft materials by means of X-ray diffraction analysis confirmed these materials to consist among others of smectites, a group of clay minerals that are classified as highly water-sensitive.

Damaged features: slabs delaminated along stylolitic planes

Fig. 6. Overview of a sample of the limestone slab after the autoclave test showing visible damage in the form of delamination along the inherent stylolitic planes.

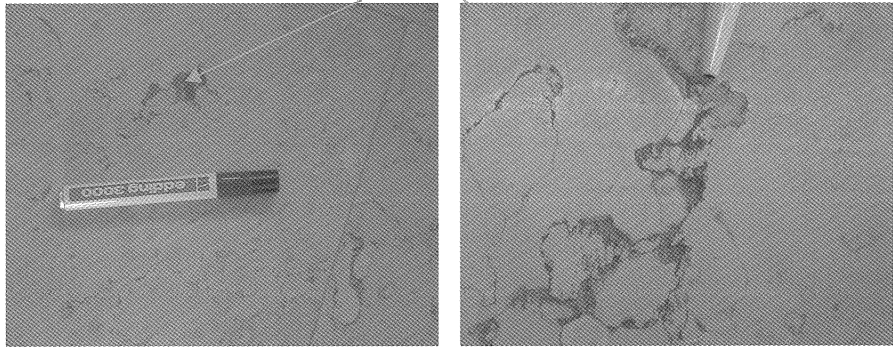
The second case study was concerned with visible damage in the surface of slabs of travertine containing stylolites that were used as floor tiles in a house. According to the house owner, prior to the damage, the floor was cleaned two to three times a month with water containing a special detergent. These cleaning activities were done upon instructions of the contractor. Barely six months after completion of the floor and put into use, the surface of the tiles began to show various forms of deterioration, which became more pronounced after about one year. The deterioration was manifested in the form of local swelling and material loss along the stylolitic planes, development of cracks along the planes of the stylolites and formation of various surface indentations (Figs. 7 and 8).

Damage features: development of cracks and indentations

Fig. 7. Overview of part of the floor in the kitchen showing samples of the travertine tiles with various forms of damage: crack development, surface indentations and material loss.

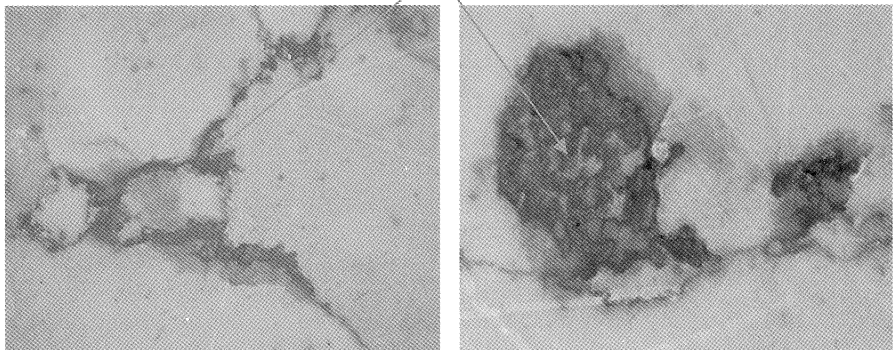
Damage features: development of cracks and materials loss

Fig. 8. Overview of part of the floor in the entrance hall and corridor showing various forms of damage in the travertine tiles: crack development and material loss in the surface.

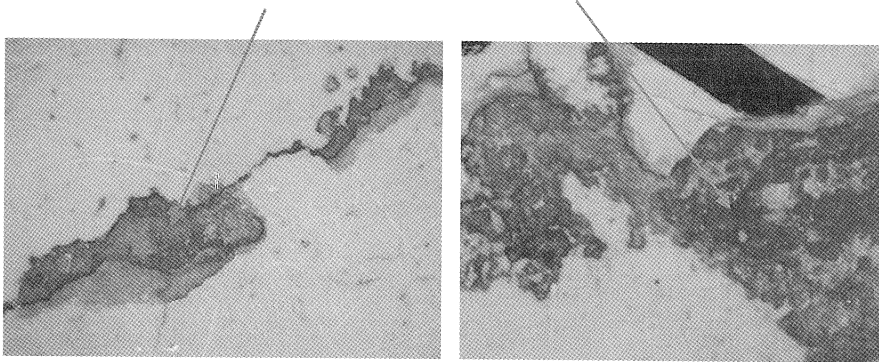
Damage features: delamination along stylolitic planes and materials loss

Fig. 9. Overview of part of samples of the travertine tiles removed from the kitchen showing various forms of damage: delamination along stylolitic planes and material loss in the surface.

With respect to the travertine slabs, the small amounts of water that gradually infiltrated the clay-rich stylolites, each time the tiles were cleaned is the cause of the deterioration. This amount of water was enough to cause the water-sensitive clays in the stylolites to swell and upon drying shrink. This process of alternating wetting and drying of the tiles, each time cleaning of the tiles occurred, caused stresses to be developed in the surface of the tiles around areas of the stylolites, which were high enough to cause surface cracking, disintegration, indentations and ultimately material loss in the surface of the tiles.

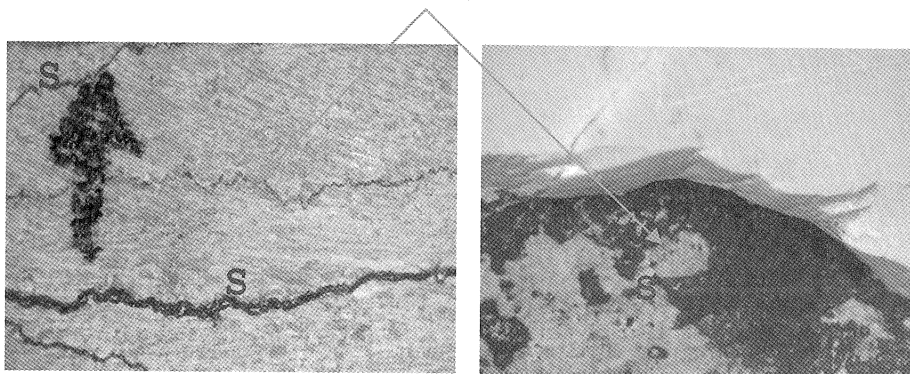
Stylolitic planes

Fig. 10. Stereomicrographs of a cross-section and overview of a travertine tiles removed from the kitchen showing expanded stylolites and delamination along a stylolitic plane, S. Size of micrographs is 15 mm x 12 mm.

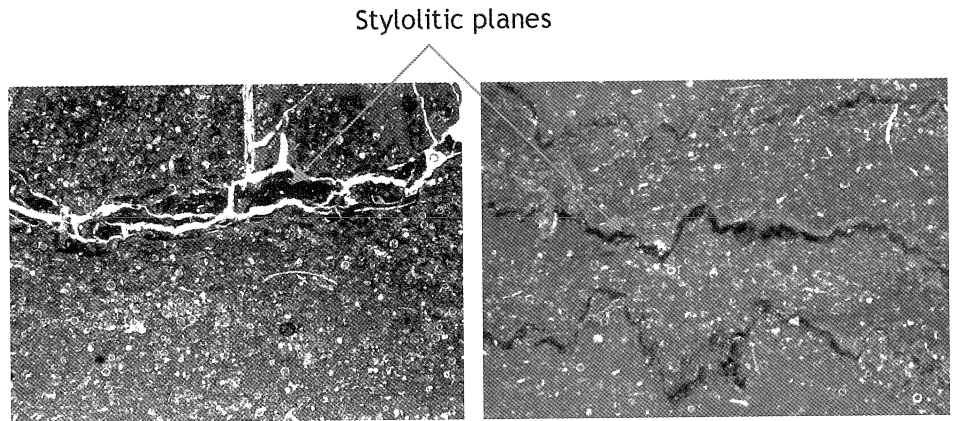
The slabs of travertine were found to consist essentially of angular microcrystalline crystals of calcite and small amounts of quartz, residues of fossils, mica, clay, opaque minerals and local traces of organic inclusions cemented together by fine grains of calcite (Fig. 11). The size of the calcite crystals ranged between 0.1 and 0.5 mm and that of the quartz grains was about 0.1 mm. A number of stylolites were clearly visible in the thin sections made. They varied in width from 0.2 mm up to about 1 mm (Fig. 11). Fine crystals of carbonates (about 50 % by volume), iron oxides, giving a reddish-brown colour (about 25 % by volume), quartz (about 10 % by volume) and clay minerals (about 20 % by volume) were found in the planes of the stylolites.

Fig. 11. PFM-micrographs of an overview of a sample of the travertine tile showing stylolitic planes containing traces of organic inclusions and oxides. Size of micrograph is 5.4 mm x 3.5 mm.

The X-ray diffraction analysis showed that the materials in the stylolitic planes were composed mainly of acid-insoluble residues of quartz and iron oxides, in addition to substantial amount of expansive clays, mainly montmorillonite, which is a highly water-sensitive clay mineral. The damage in the surface of the travertine slabs appeared to be related to the presence of the water-sensitive clay mineral in the planes of stylolites in the travertine slabs.
