Replacement of natural stone in conservation of historic buildings

Evaluation of replacement of natural stone at the church of Our Lady in Breda

W.J. (Wido) Quist

Delft University of Technology, the Netherlands

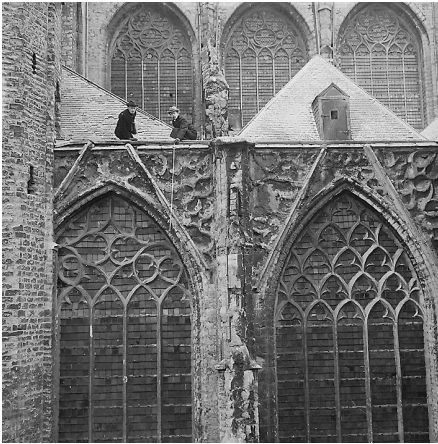
- Rainwater entered the building and weathered the stone because the connection between the roof and the façade was leaky. Many repairs were executed during the past years with cement mortar;
- The mouldings of the canopies were almost totally eroded;

- The window arches and traceries were all in a bad condition. Partly because of rusting iron and partly because of water seeping through the material due to the absence of well functioning dripstone mouldings;
- The leaded glass had loosened from the traceries. Many glass sheets were broken or gone. Some of the windows were filled with brick masonry;
- The fillings of the canopies and spandrels had almost totally gone.

Figure 4: Niervaartkapel, 1909, before the first conservation campaign (photo: RCE)

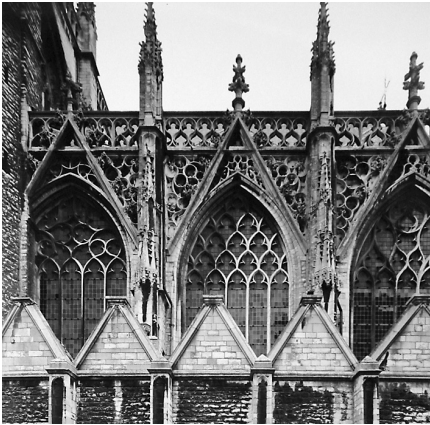
Figure 6: Niervaartkapel, 1992, before the second conservation campaign (photo: architectenburo J. van Stigt b.v.)

Figure 6 shows the south façade of the *Niervoartkapel* in 1992 after having been exposed to weathering for approx. 75-80 years. The appearance of the façade changed over the years due to the weather conditions and environmental pollution; the sculptural work was hidden behind a black fog of dirt and gypsum. Most of the pinnacles and finials had weathered in such a way that they had to be removed and replaced by copies. Figure 6 shows the 2006 situation where the upper pinnacles and finials have been renewed in Tepla trachyte. Some of the dripstone mouldings and large parts of the lower pinnacles have also been replaced by copies in Tepla trachyte during the conservation campaign of 1995-1998. Besides the replacements, repairs have been carried out in Monulit mortar⁸.

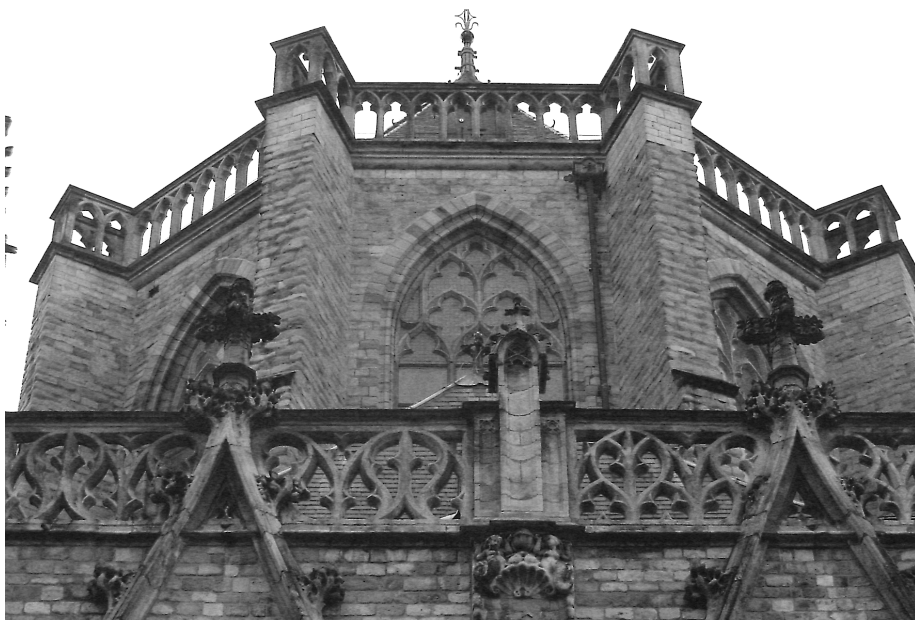
Looking at the 1991 situation before restoration (see figure 2) and the current situation after restoration (see figure 10) it can be concluded that the Obernkirchen sandstone blends wonderfully well into the background of Lede and Gobertange stone while the stone itself does not appear to have degraded.

Figure 10: View on the high windows of the choir in Obernkirchen sandstone (photo: author, december 2005)

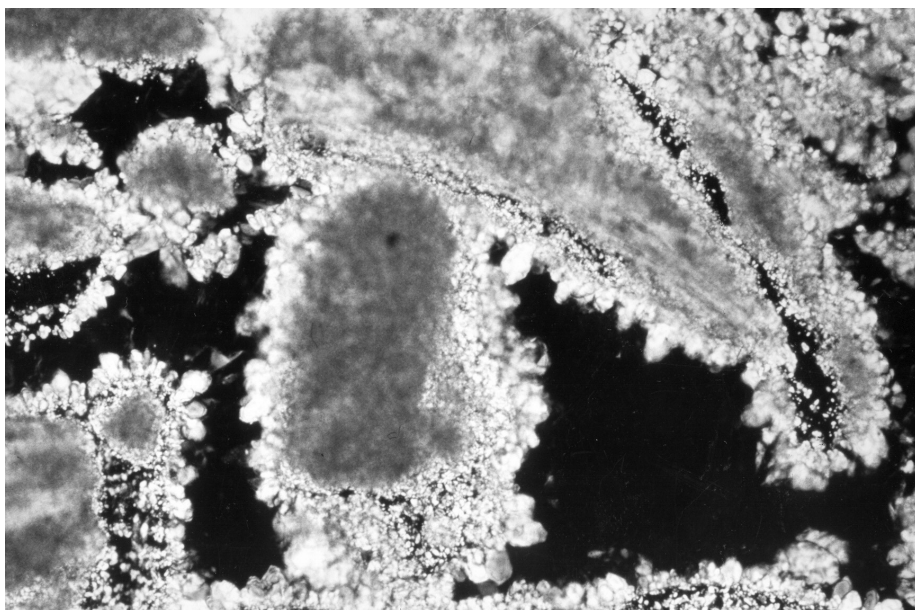
Preceding the start of the second large conservation campaign, TNO assessed the state of conservation of natural stone at the Church of Our Lady [Naldini and Van Hees, 1993]. Based on optical and electron microscopy (see figure 11 and [Larbi et al., 2003]) and freeze-thaw cycles on the ornaments was concluded that “... *the situation is alarming: due to the structural damages, the severely decayed ornaments can easily collapse. The most compromised pieces should be substituted.*”

Figure 11: PFM-micro photo of a sample of oolitic limestone, size of the micrograph is 1,4 x 0,9 mm (photo: TNO)

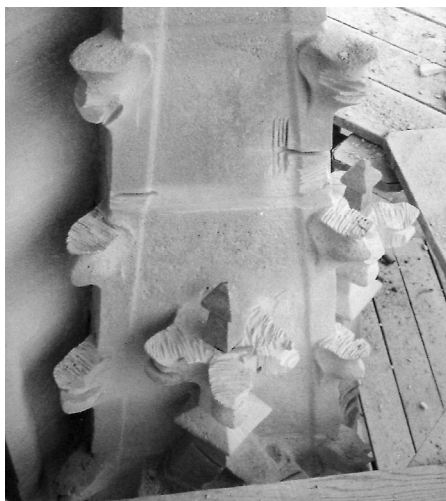
Many ornaments were kept in place partly and only single (lead) finials and crockets have been replaced. Many crockets were moulded using Monulit mortar (see figure 13)

Figure 13: Moulding crockets with Monulit mortar (photo: Architectenburo J. van Stigt b.v.)

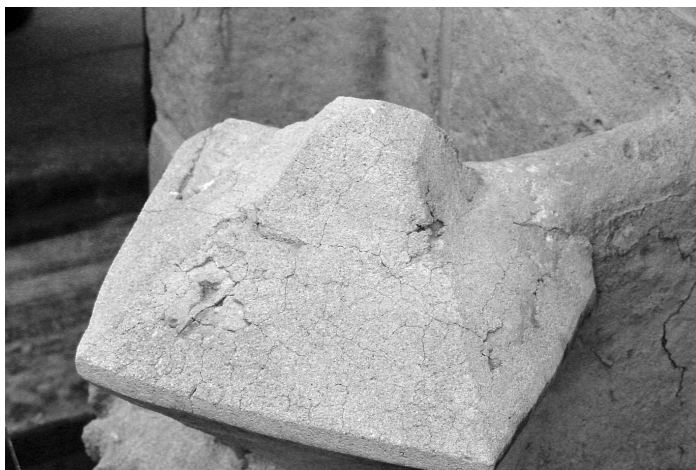
Also other components of the intervention, e.g. the use of Monulit mortar for stone repair leave some doubts as to whether compatibility was thought of: the components of the repair mortar may lead to the formation of hygroscopic calcium chloride³³, a very hygroscopic salt.

Figure 14: Incompatible use of Monulit mortar. (photo: author)

For the time being, i.e. ten years after execution of the repairs, it can be observed that the repairs are still intact and aesthetically acceptable. Pre-requisite for a durable repair however is the application in a sufficient thickness (see figure 14 and 15).

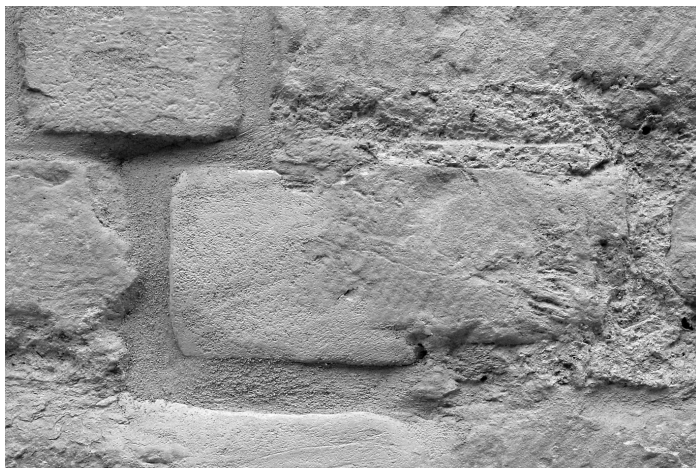
Figure 15: Compatible use of Monulit mortar. (photo: author)

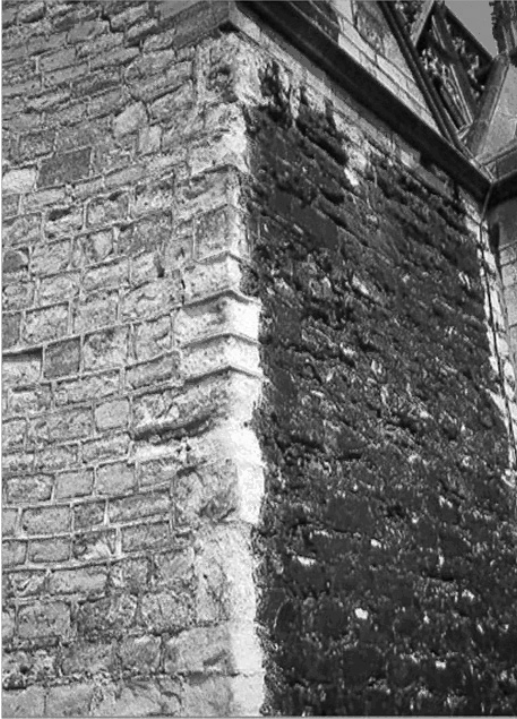
An important observation made by Van Stigt was further that the hard and stiff cement re-pointing, applied during the previous campaign had provoked damage to the surrounding Lede and Gobertange stone (and hence could be considered incompatible), see fig. 16.

Figure 16: South façade transept. Consequence of use of incompatible re-pointing: damage to Lede stone – situation 1991. (photo: Rob van Hees)
