### CORROSION PROTECTION OF UNBONDED TENDONS

*C. F. Etienne*<sup>1</sup>, *D. C. Binnekamp*<sup>2</sup>, *W. J. Copier*<sup>3</sup>,  
*R. Hendrickx*<sup>4</sup> and *C. L. Smit*<sup>5</sup>

Abridged version of a report prepared by the Netherlands Committee for Corrosion Protection of Unbonded Tendons (Committee C 26A) for the Netherlands Committee for Research, Codes and Specifications for Concrete (CUR-VB)

## **CORROSION PROTECTION OF UNBONDED TENDONS**

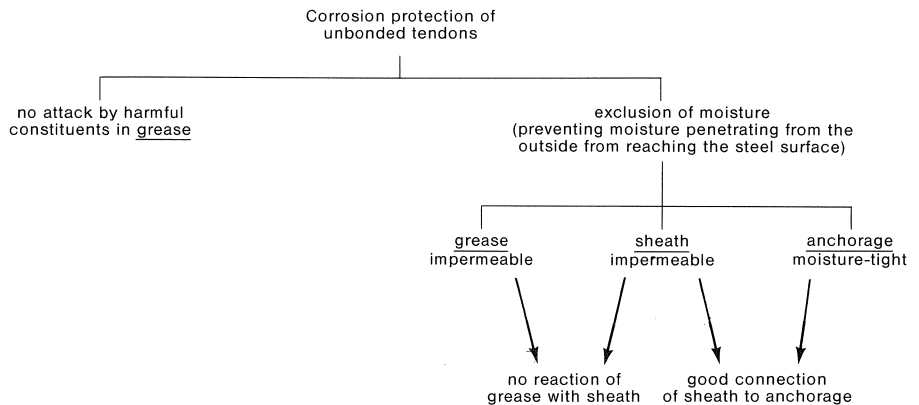
Fig. 4. Desired corrosion protection effects for unbonded tendons.

In assessing the corrosion protection it is necessary to distinguish between the *grease* with which the steel is coated, the *sheath* enclosing the steel with the grease, and the situation at the *anchorage*. The desired protective effects for unbonded tendons are indicated in Fig. 4 and will be examined in more detail below.

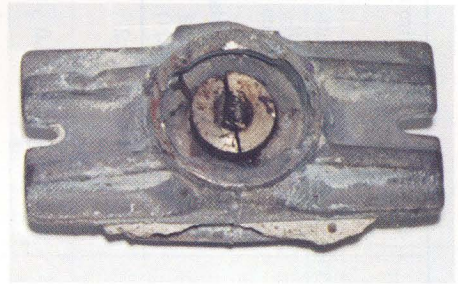
a. front view of anchorages

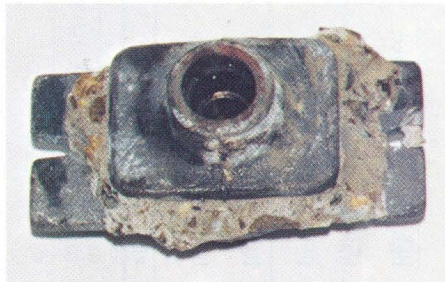
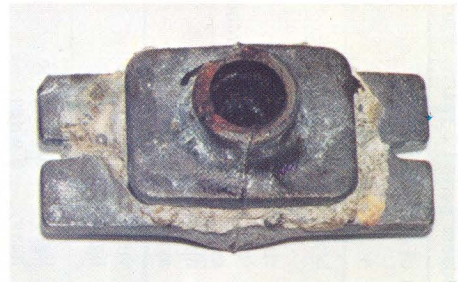
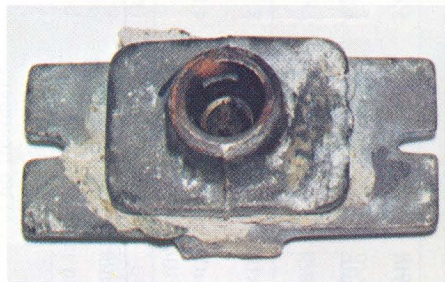
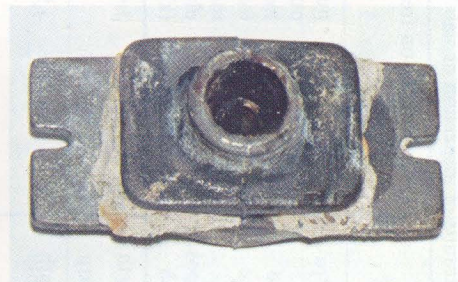
b. rear view of anchorages
