# Unexpectedly low tensile strength in concrete structures

Ton Siemes, Ningxu Han and Jeanette Visser  
TNO Building and Construction Research

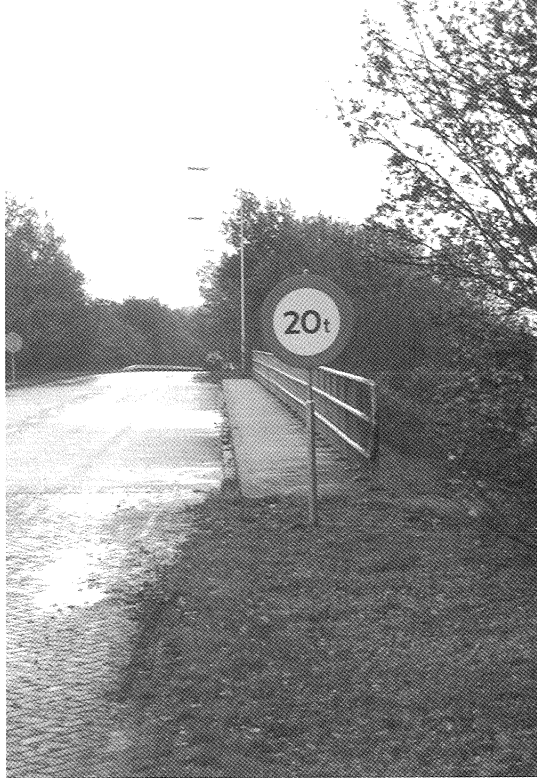
*Figure 1. Load limitation to 20 tonsting on a viaduct due to a reduction of the load-bearing capacity from ASR*

For many years it was believed that an unambiguous relationship exists between the compressive strength and the tensile strength of concrete. The solid confidence on this relationship leads to the direct derivation of the tensile strength from the compressive strength in many national or international concrete codes. It was therefore a big surprise when research on concrete structures, that were damaged by alkali-silica reaction (ASR), showed that the uniaxial tensile strength can be significantly lower than could be expected on the basis of the present compressive strength or on basis of the measured splitting tensile strength [Siemes and Bakker (1997)]. The uniaxial tensile strength in those structures proved to be so low that radical safety measures had to be taken, like demolition, payload reduction (Figure 1), strengthening or monitoring.
