# Decay of Rhenish tuff in Dutch monuments.

## Part 1: Use, composition and weathering

Timo G. Nijland<sup>1</sup>, Sonja Brendle<sup>1</sup>, Rob P.J. van Hees<sup>1,2</sup> & Geert-Jan L.M. de Haas<sup>3</sup>

<sup>1</sup> TNO Building & Construction Research, Delft, The Netherlands

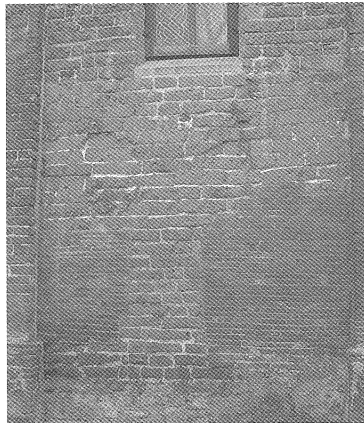
*Fig. 1. Surviving 11<sup>th</sup> century Römer tuff on the north façade of John's church, Utrecht.*

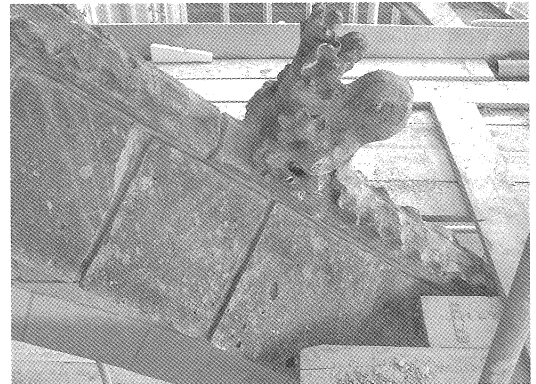
*Fig. 2. Römer and Weiberner tuff on one of the rampant arches of St. John's cathedral, s Hertogenbosch, probably dating back to the 14<sup>th</sup> – 15<sup>th</sup> century.*

tuff s.sr. has been used in the same period. Original Weiberner tuff is, together with Hohen Ley and Römer tuffs, still present in the rampant arches of St. John's cathedral, 's Hertogenbosch (Fig. 2).

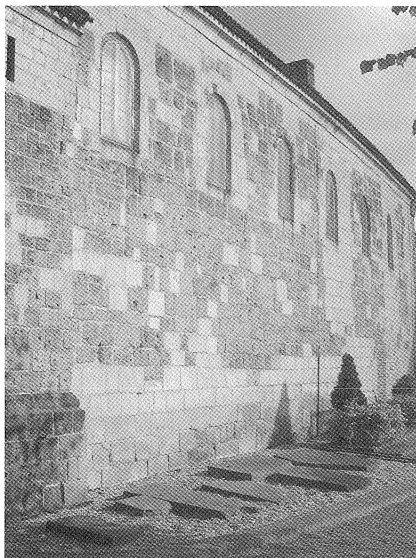
*Fig. 3. Mixture of recycled Römer tuff and Weiberner tuff in the Old Church, Oosterbeek, rebuilt after serving as a British bridgehead in the late 2<sup>nd</sup> World War.*

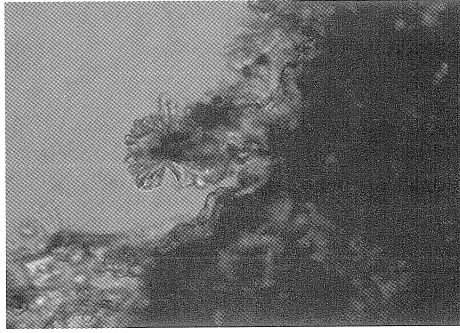
Fig. 7. Microphotograph showing well developed zeolites in the matrix of fresh quarry material of Römer tuff (sample TUF 72, view 0.7 x 0.45 mm).

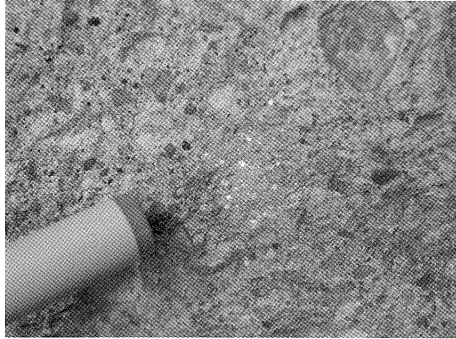
Fig. 11. Example of rock fragment considered typical for Hasenstopplertuff.

Macroscopically, the matrix has a light brown colour with abundant, regularly distributed rock and pumice fragments; single fragments are sized up to a few centimetres. The tuff denoted as Hasenstoppler is considered to be a variety of Ettringer tuff (Slinger et al. 1980), only distinguished by specific rock fragments (Fig. 11).

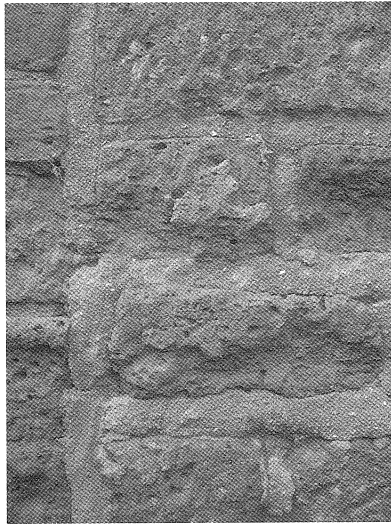
*Fig. 13. Spalling of Römer tuff, church tower at Tienhoven.*

- Spalling is common on Römer tuff (Fig. 13), in contrast to Weiberner (on which it is rare) and Ettringer (on which it has not been observed).
- Aveoli are also common, due to the selective weathering of pumice fragments. They are common on Römer and Ettringer tuff (Fig. 14), not on Weiberner tuff.
- Exfoliation (or scaling) is common on Weiberner tuff, and appears to be related to rising moisture and salt crystallisation (Fig. 15).
- Salt efflorescence is common (see below)
- Powdering of the matrix occurs over large surfaces of tuff masonry, in particular those of Römer tuff (Fig. 16).

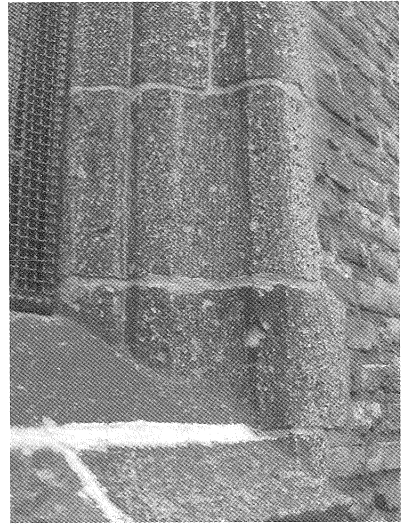
*Fig. 14. Aveoli on Ettringer tuff, Old Church, Delft.*

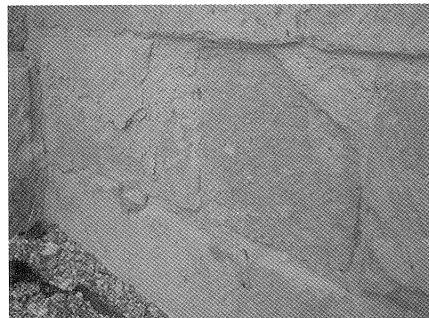
*Fig. 15. Exfoliation of Weiberner tuff, Old Church, Oosterbeek.*

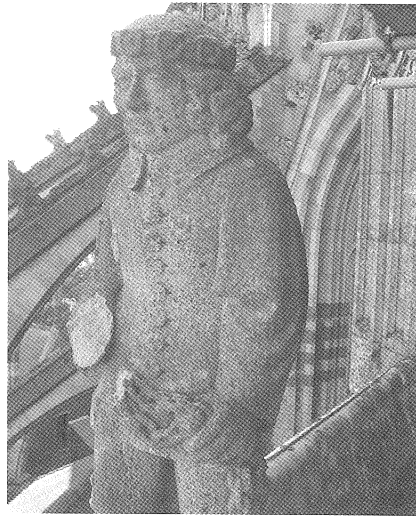
*Fig. 17. Cracking in Ettringer tuff, left a lintel at the St. John's centre, 's Hertogenbosch, right a sculpture at St. John's cathedral, 's Hertogenbosch.*

- Dissolution of matrix occurs at all types of Rhenish tuff, especially where accumulation of water occurs and drying conditions are slow.
- Grey deposits can be found on all Rhenish tuffs, and usually contain gypsum.
- Large cracks occur in Ettringer and Hasenstoppler tuff in particular, often resulting in the loss of extending parts of sculptures and worked stones (Fig. 17).
- Biological growth easily develops on all kinds of Rhenish tuff, which are apparently more bioreceptive than other types of natural stone (Fig. 18).

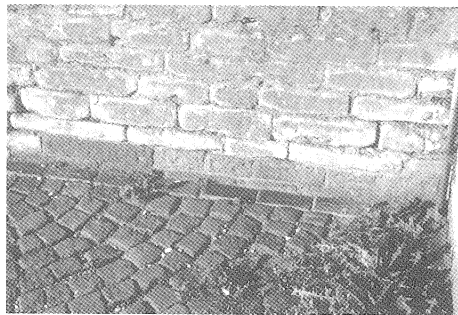
*Fig. 19. Römer tuff with hard, glassy surface at street level below Gobertange sandy limestone of the St. Lambertus tower, Vught.*

In general, weathering and decay are most severe in zones with a high, frequent exposure to moisture. However, in addition to the weathering forms described above, which are expressions of negative effects on durability, one particular form of aging of Römer and Weiberner tuff was observed, which apparently preserves this tuff from further weathering, even at positions where the tuff is exposed to high moisture levels. The surface of the tuff becomes hard, sometimes with an glassy appearance, in which a fine mazed craquélé crack pattern occasionally developed. This type of aging has been observed at street level in the church towers of the St. Lambertus church (Fig. 19), Vught, the Old Church, Oosterbeek, the church at Tienhoven and the Lebuïnus church, Deventer as well as on the rampant arches of St. John's cathedral, 's Hertogenbosch. In case of the latter, the tuff

dates back to the original building period. In case of the St. Lambertus tower, this tuff was apparently left in place during restoration works in 1954, when tuff at higher levels was replaced. Since, it did apparently not decay. Research into the nature of this type of aging is in progress.
