Self-healing of lime based mortars: microscopy observations on case studies

B. Lubelli ^{1,2}, T.G. Nijland ², R.P.J. van Hees ^{1,2}

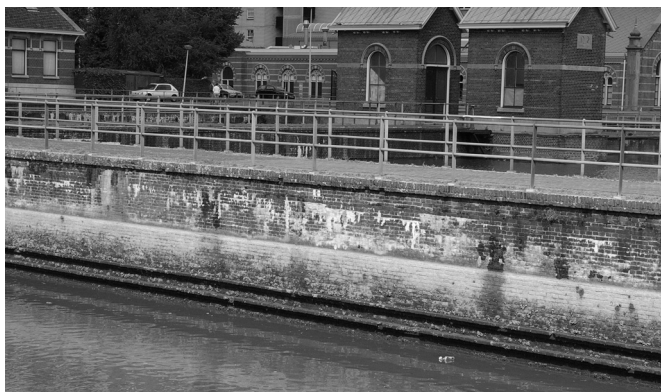
Figure 1: Masonry wall of the drink water company in Rotterdam

This brick masonry structure dates back to 1873; the mortar binder is air lime with the addition of some trass providing hydraulic properties to the mortar. The masonry is partially immersed in water, and it has therefore a high moisture content. Calcite encrustations are visible on the masonry surface (Fig. 1), due to leaching of the mortar binder.

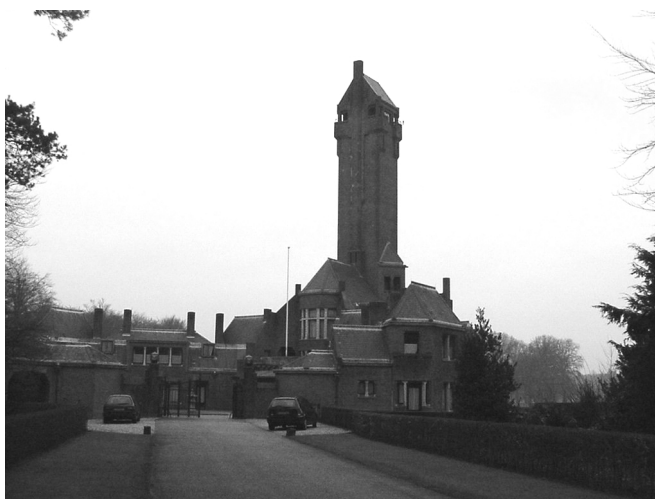
Figure 3: Hunting Lodge St. Hubertus – overview

The hunting lodge St. Hubertus is a brick masonry building dating back to 1915-1920 (Fig. 3). The mortar binder is hydraulic lime. Calcite encrustations, due to leaching of the mortar, are visible at the surface of the masonry of the walls of the balcony (Fig. 4). Here a high moisture content (between 7 and 15 wt%) was measured.

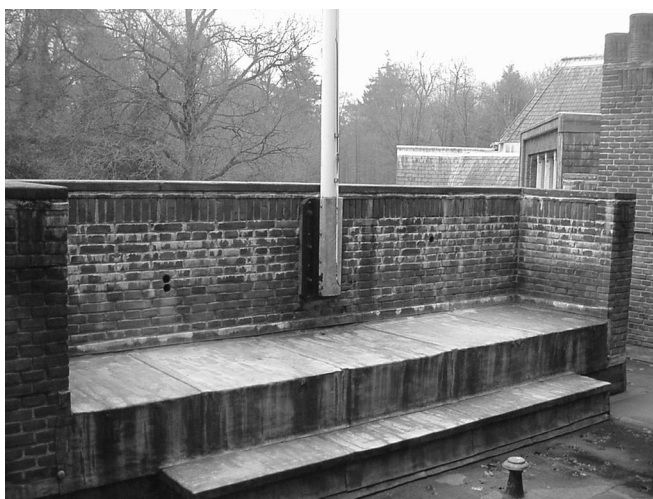
Figure 4: Hunting Lodge St. Hubertus – balcony wall

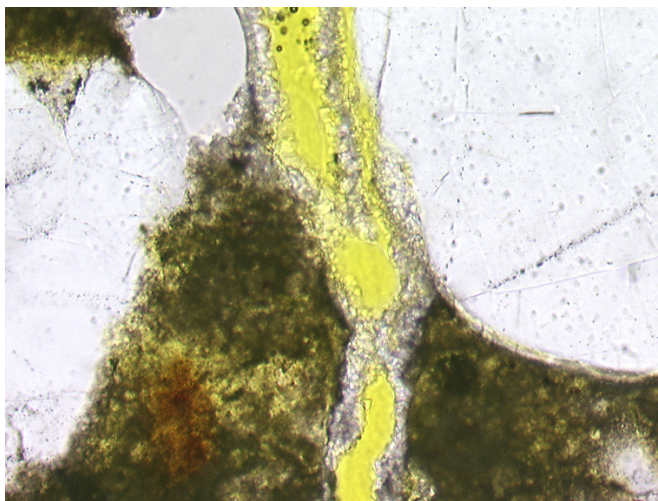
Figure 5: Polarization-and-fluorescence microscopy (PFM) image showing re-precipitation of calcite on crack walls; 200x magnification (0.7 x 0.45 mm), cross polarized light (Hunting Lodge St. Hubertus)

In the thin sections of the cores sampled from the balcony wall, re-precipitation of CaCO_3 has been observed. Small CaCO_3 crystals have grown in voids, cracks (Fig. 5) and lime lumps (Fig. 6). The CaCO_3 crystals do not completely fill the cracks, but only reduce their width.

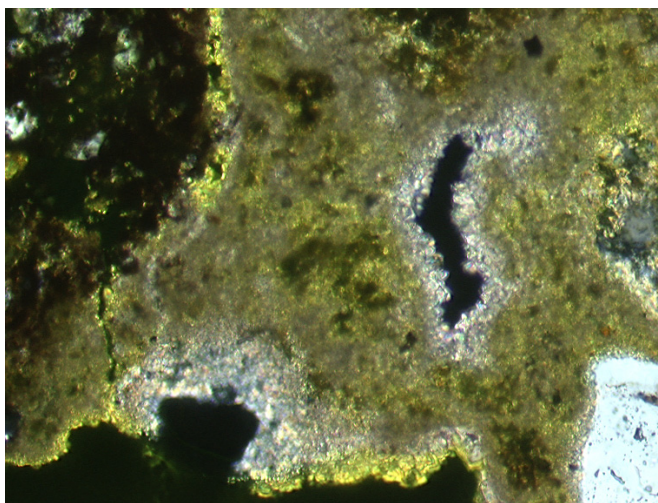
Figure 6: PFM image showing re-precipitation of calcite in voids; 200x magnification (0.7 x 0.45 mm), cross polarized light (Hunting lodge St Hubertus)

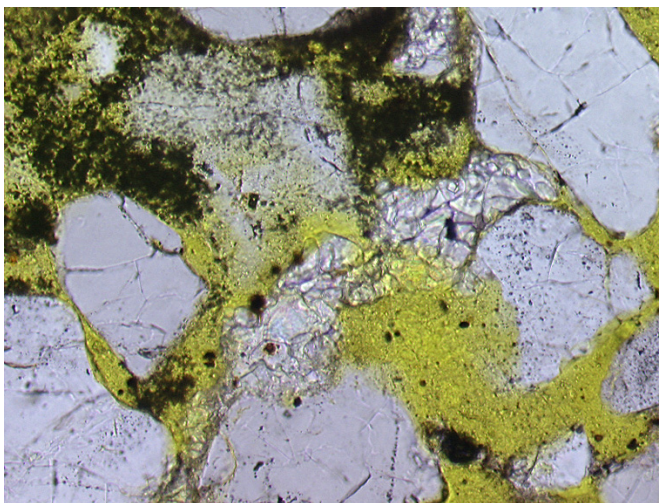
*Figure 7: PFM image showing re-precipitated CaCO_3 entirely filling a crack;
200x magnification (0.7 x 0.45 mm), plane polarized light
(Defence wall, Den Bosch)*

In the cores sampled at the masonry surface, re-precipitation of CaCO_3 in cracks has been observed. The CaCO_3 has crystallized as relatively well developed, rhombohedral crystals, nucleating on the crack walls and growing outwards to completely (Fig. 7 and 8) or partially (Fig. 9) fill the cracks. In the core sampled in depth in the masonry (65 cm from the surface) well developed, large $\text{Ca}(\text{OH})_2$ crystals have been observed, filling voids and cracks (Fig. 10 and 11).

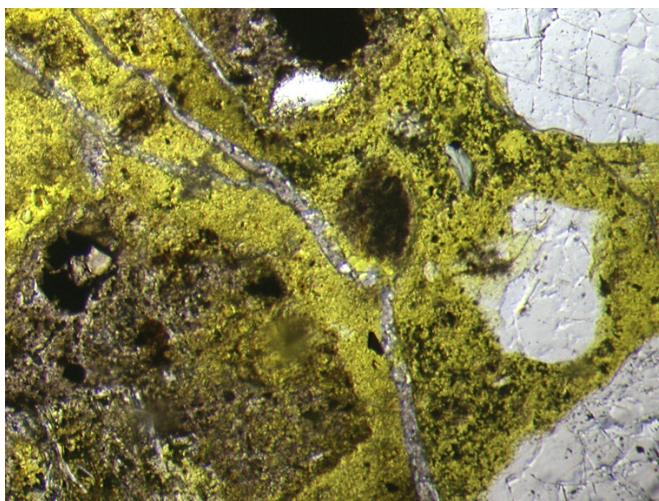
*Figure 8: PFM image showing re-precipitated CaCO_3 effectively filling a crack;
100x magnification (1.4 x 0.9 mm), plane polarized light
(Defence wall, Den Bosch)*

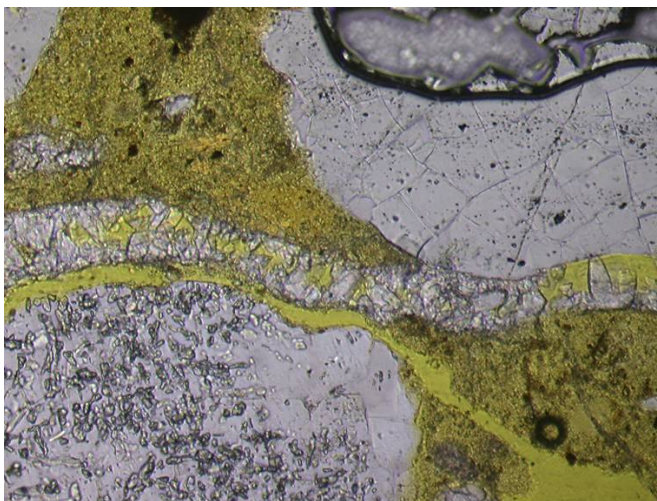
Figure 9: PFM image showing re-precipitated CaCO_3 effectively closing a crack without completely filling it; 200x magnification (0.7 x 0.45 mm), plane polarized light (Defence wall, Den Bosch); note the relatively well developed crystal faces.

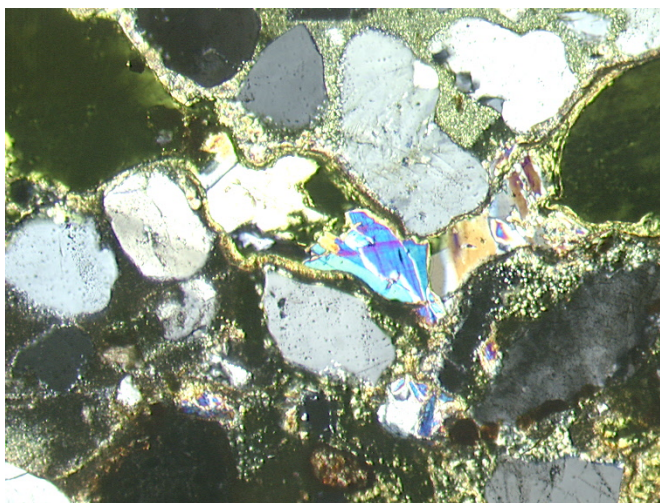
Figure 10: PFM image showing Ca(OH)_2 completely filling a void; 100x magnification (1.4 x 0.9 mm), cross polarized light (Defence wall Den Bosch, about 65 cm from the surface of the wall). Note the remarkably large size of the portlandite crystals, with single crystals bridging the void, their longest crystal axis oriented more or less perpendicular to the void walls

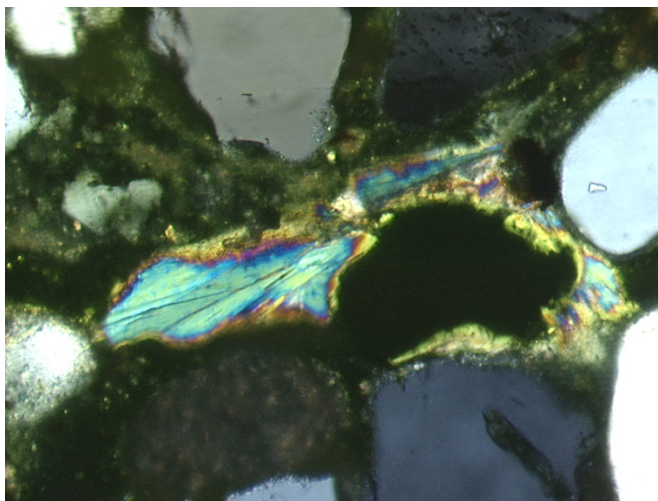
*Figure 11: PFM image showing re-precipitation of portlandite in a void;
200x magnification (0.7 x 0.45 mm), cross polarized light
(Defence wall Den Bosch, about 65 cm from the surface of the wall)*

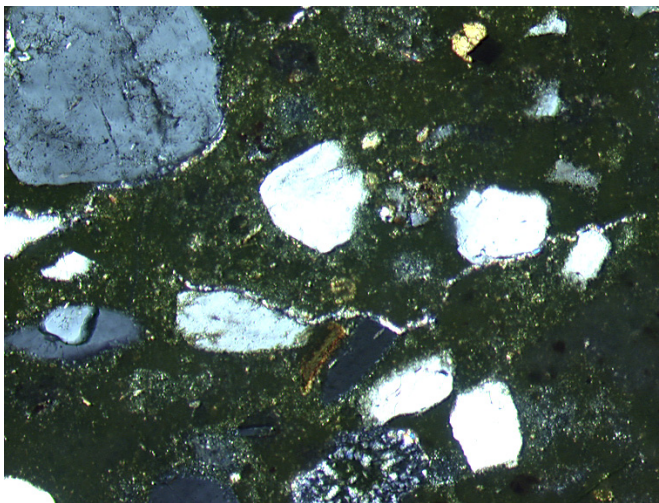
*Figure 12: Polarization-and-fluorescence microscopy (PFM) image
showing narrow crack filled by carbonate;
100x magnification (1.4 x 0.9 mm), cross polarized light
(Defence wall, Bergen op Zoom)*

In the thin sections, besides wider open cracks, narrow cracks are present filled by secondary phases. Both CaCO_3 (Fig. 12) and portlandite (Fig. 13) crystals fill some of the narrowest cracks; they do, however, never occur together in the same crack, nor in mutual contact. Both CaCO_3 and portlandite crystals are very small. Larger CaCO_3 crystals also occur in layered precipitates at the mortar – brick interface and in voids. Portlandite occurs at locations far from the masonry surface. Portlandite filled cracks are subordinate to carbonate filled ones. In addition to cracks filled by either calcium carbonate or portlandite, cracks filled by gypsum occur. Given the potential of gypsum for further sulfate attack, these cannot be considered a self-healing feature (cf. Nijland et al. 2007).

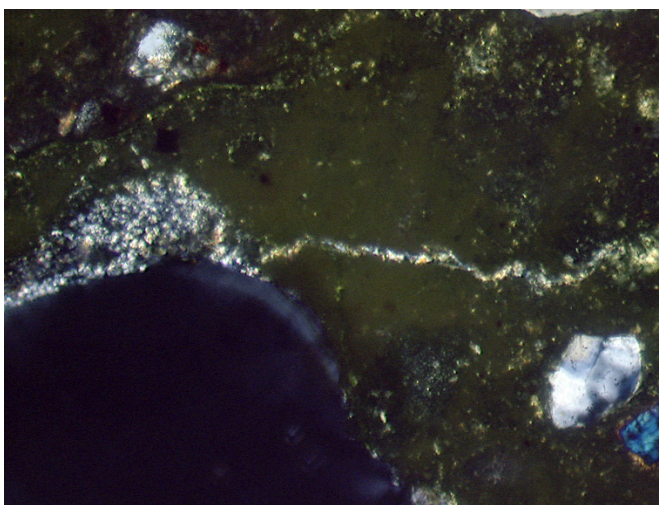
*Figure 13: Microphotograph showing a crack in 19th century lime mortar,
filled completely by fine grained portlandite;
200x magnification (0.9 x 0.45 mm), cross polarized light
(Defence wall, Bergen op Zoom)*

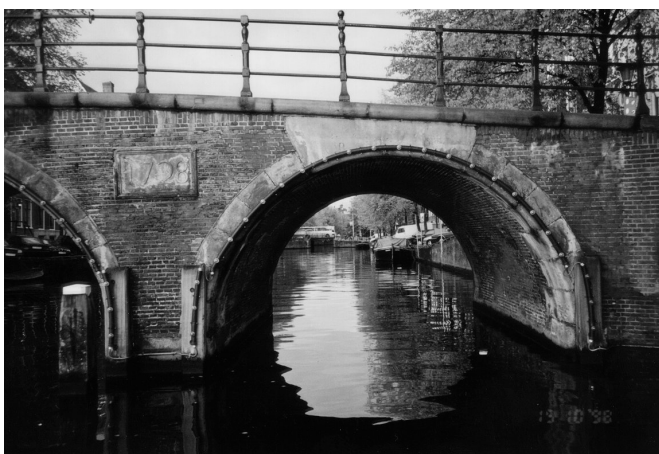
Figure 14. The bridge in Amsterdam

The bridge (Fig. 14), located in Amsterdam, dates back to 1728. It is a masonry structure composed by fired clay bricks and trass-lime mortar. The moisture content in the masonry structure is very high (up to 42 wt%). On the surface of the masonry encrustations, due to leaching of the mortar, are visible.

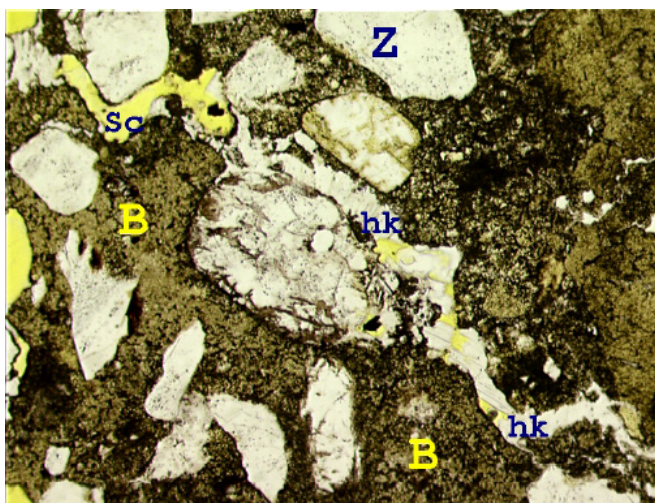
Figure 15. Microphotograph showing a crack filled by calcite;
50x magnification (2.7 x 1.4 mm), cross polarized light (Bridge, Amsterdam)

In the thin section re-precipitation of CaCO_3 in cracks has been observed. The CaCO_3 crystals have grown to close the cracks and fill them almost completely (Fig. 15).
