Replacement of natural stone in conservation of historic buildings

Evaluation of replacement of natural stone at the church of Our Lady in Breda

W.J. (Wido) Quist

Delft University of Technology, the Netherlands

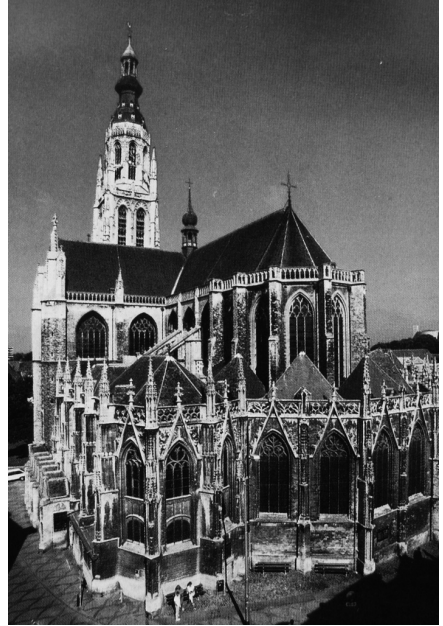
Figure 2: Church of Our Lady, 1991 (postcard from the archives of the Church of Our Lady, Rolf ter Veer, Breda, 1991)

Looking at the 1991 situation before restoration (see figure 2) and the current situation after restoration (see figure 10) it can be concluded that the Obernkirchen sandstone blends wonderfully well into the background of Lede and Gobertange stone while the stone itself does not appear to have degraded.

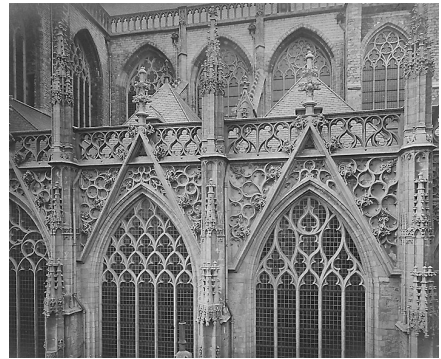
Figure 5: Niervaartkapel, 1918, shortly after the first conservation campaign (photo: RCE)

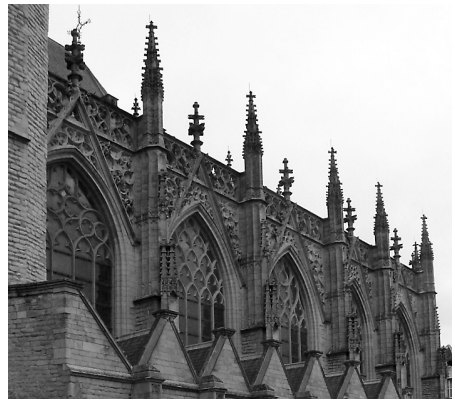
Figure 7: Niervaartkapel, 2006 (photo: author)

The series of photos (figure 4-7) also shows the transformation of the glazing. The 1909 situation shows crossing bars combined with saddle bars, some glass sheets are missing and repairs are clearly visible. Except for some pollution effects the 1918 and the 1992 situation are the same. Saddle bars no longer support the leaded glass and the construction of rivet and wedge has been changed. The photo from 2006 shows another image; protective glazing and nylon net against pigeons have been added in the period 1995-1998. For an in depth analysis of the glazing see Quist and Van Hees [2006] and Quist [2006].

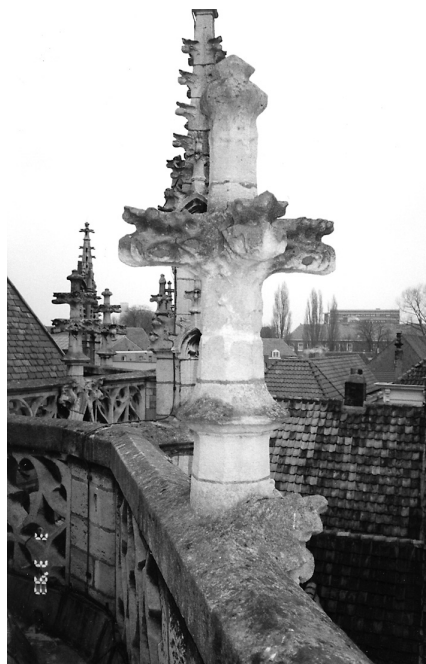
Figure 9: Finial on the choir aisle, 1993 (photo: Rob van Hees)

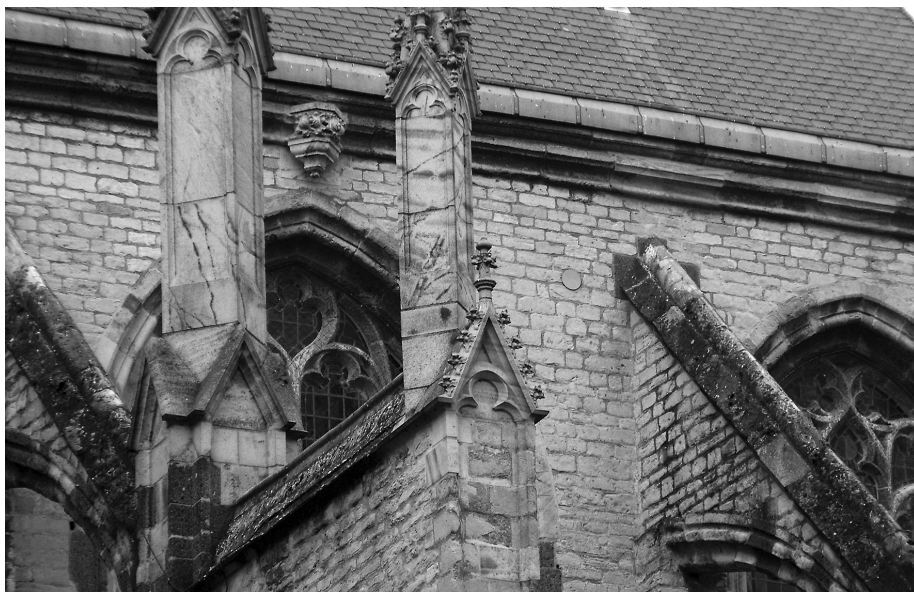
Tepla trachyte has also been used as replacement stone at the Cathedral of Xanten in Germany [Gilhuber et al, 2006], for the restoration of the City hall of Gouda (1995), the restoration of the Basilica of St. Willibrord in Hulst (1996-1999), the Protestant Church in Elst and the train station in Groningen (1995).³¹ Around 130 m³ of Tepla trachyte has been used in Hulst, mainly as replacement stone for Etringer Tuff stone from the 1930's [Hamelink, 2005], see figure 12.

Figure 12: Tepla trachyte at the Basilica of St. Willibrord in Hulst. (photo author)
