Experimental tests on masonry strengthened with bed joint reinforced repointing

L. Licciardello, J.G. Rots, R. Esposito
Delft University of Technology, the Netherlands

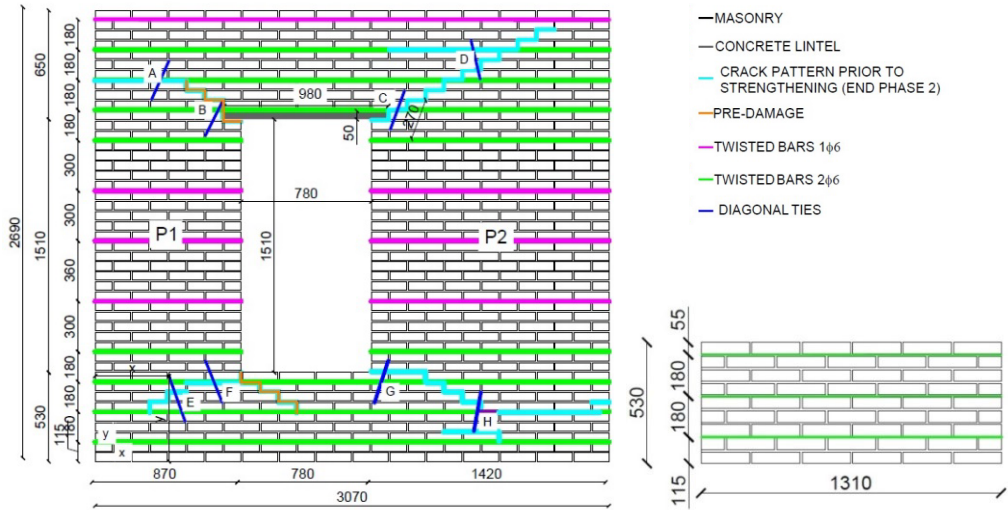
Figure 1. Overview of tested specimens: (a) dimensions and strengthening configuration; (b) detail of the strengthened bed joint; (c) execution of the intervention

To study the seismic performances of masonry strengthened with bed joint reinforcement, the results of quasi-static cyclic in-plane tests on a full-scale wall with opening were considered (Figure 1a). Two different walls were used: a pre-damaged and subsequently strengthened wall (TUD-COMP-45) and an undamaged and unstrengthened wall (TUD_COMP-41) (Korswagen et al. 2017, Korswagen et al. 2018, Messali 2018). Both the walls had dimensions equal to 3070 x 2690 x 100 mm with a window opening of 780 x 1510 x 100 mm; the opening was placed asymmetric leading to the presence of a narrow pier P1 and a wider pier P2 (where the term pier is here adopted to define portion of masonry located next to the window and having the same height of the opening). A prefabricated concrete lintel (980 x 50 x 100 mm) was built at the top of the window. This wall typology is typical of detached house, which is a common residential typology in the Netherlands (Kallioras et al. 2018). To evaluate the response of the wall for low intensity and repetitive earthquakes, typical of the Groningen area, two cyclic protocols were applied: one to evaluate the response up to the light damage phase (phase 1 and 2) and one to evaluate the response up to near collapse (phase 3). In the light damage phase, a maximum crack width of approximately 2 mm was reached (Korswagen et al. 2017, Korswagen et al. 2018). To reproduce the damage caused by settlement before an earthquake, the wall TUD_COMP-

45 was pre-damaged by creating un-bonded brick-joint interfaces using thin plastic strips (orange lines in Figure 1a). The wall TUD_COMP-45 was firstly tested up to light damage state, (light blue lines in Figure 1a) and then strengthened with bed joint reinforced repointing. Afterwards, the wall TUD_COMP-45 was re-tested up to light damage state and subsequently brought to near collapse state. The unstrengthened wall TUD_COMP-41 was tested under similar conditions for both the light damage and the near collapse state, but was not initially pre-damaged. To make a comparison in terms of serviceability limit state, the performance of wall TUD_COMP-45 before and after the strengthening should be considered; on the contrary, for the near collapse state the performance of strengthened wall TUD_COMP-45 and unstrengthened wall TUD_COMP-41 should be considered. To quantify the improved performance of the strengthened masonry, comparisons are made in terms of equivalent bilinear curve (Magenes et al. 2008, Morandi et al. 2018) and damage levels (Lagomarsino and Cattari 2015).

To study the performance of masonry strengthened with bed joint reinforcement against settlement, four-point bending tests on masonry wallets were performed (Figure 1a). These specimens represented the area below the window opening, which is the more prone to vertical cracks caused by settlement, shrinkage or expansion due to environmental conditions. Before the installation of the strengthening measure the wallets were neither pre-damaged nor tested.

For both the wall and the wallets the bed joint reinforcement was lay out as in practice; additionally diagonal ties were installed in the wall across existing diagonal stepwise cracks near the opening's corners (Figure 1a). Considering that the areas above and below the window opening are generally the most prone to settlement damage, often bed joint reinforcements are installed in these areas by placing one or two bars every two or three courses of masonry. For the wall and the wallets two twisted steel bars every three masonry courses were installed (green lines in Figure 1a). For the wall, one steel bars every five or six masonry courses was installed in piers that are defined as the vertical masonry portion next to the window opening (pink lines in Figure 1a). In addition, diagonal ties (blue lines Figure 1a) were placed in correspondence of the diagonal cracks to keep them as close as possible.

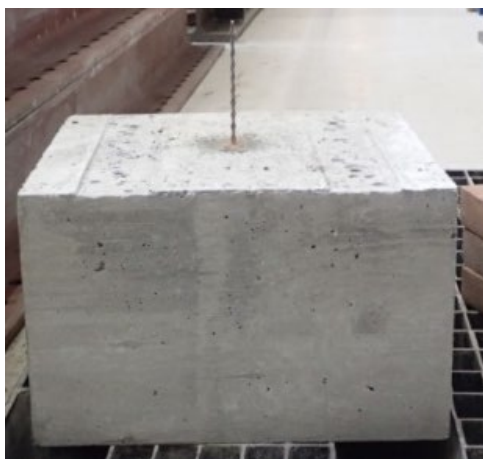
(a) Diagonal ties

Figure 2. pull-out test specimen

Since previous research showed that the bond behaviour between the twisted steel bars and the repair mortar plays an important role in the effectiveness of the strengthening method (Moreira et al. 2014), within this study pull-out tests have been performed to characterise the response of both twisted steel bars embedded in the repair mortar, and of the diagonal ties in the masonry. For the steel bars, six pull-out tests were performed in agreement with the standard EN 1766 (NEN 2015) by adopting auxiliary concrete cubes with dimensions 400 x 400 x 250 mm (Figure 2a). After the casting, three concrete cubes were cured in wet condition (under water) and the other three in dry condition (in air) in a conditioning room at $(20 \pm 2)^\circ$ with 95% humidity for 28 days. For the diagonal ties, pull-out tests were performed on tie vertically installed in a masonry triplet with dimensions 210 x 170 x 100 mm (Figure 2b). The tests were performed by adopting the same set-up and testing procedure used by Skroumpelou et al. (2018). Monotonic pull-out tests were carried out for both specimens; additionally cyclic pull-out tests were performed for diagonal ties.

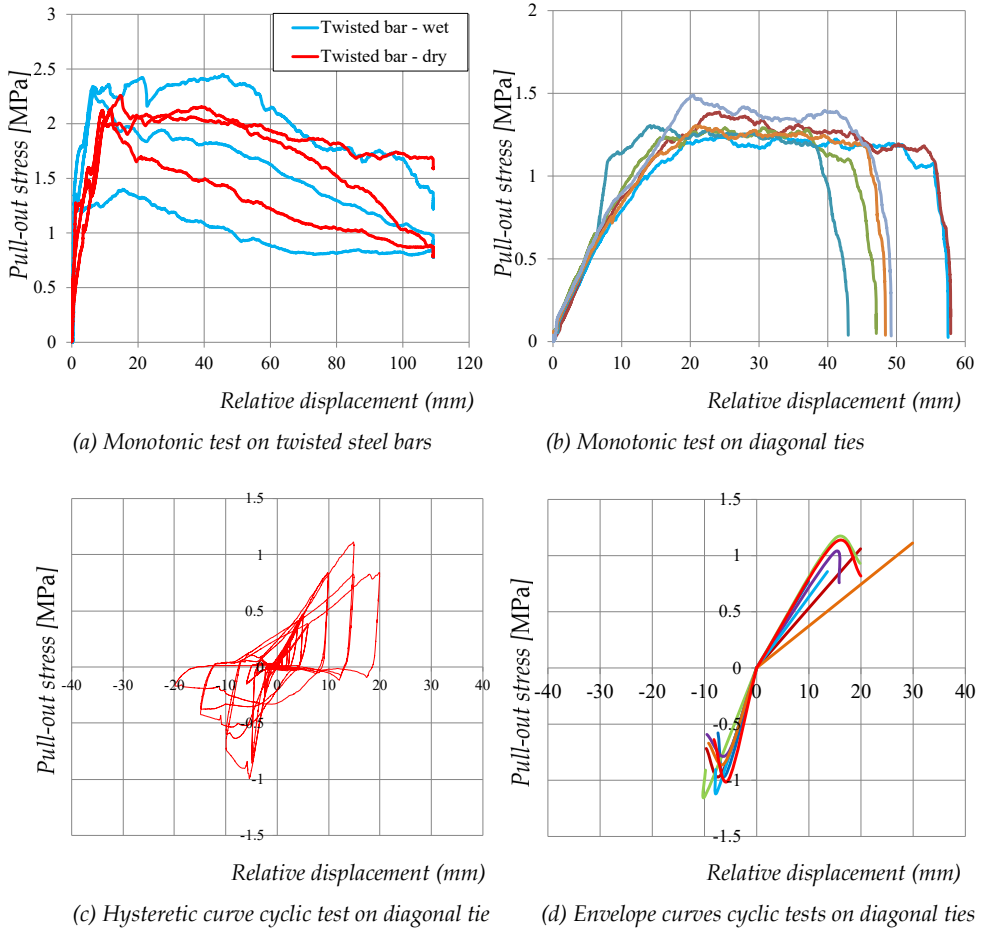
Figure 3. Pull-out stress versus relative displacement curve Pull-out stress [MPa]

For both the twisted bars and the diagonal ties slip and elongation of the bar occurred under monotonic tensile loading. In the case of the diagonal ties under cyclic loading, a similar behaviour was observed under tensile loading, while buckling and final rupture of

the tie was reported under compression loading. The results are reported in terms of pull-out stress versus relative displacement curve (Figure 3). For the cyclic tests, the envelope curve was calculated considering the force and the displacement in correspondence of the peak force and in correspondence of a drop of 20% of the maximum force (Skroumpelou et al. 2018). The curves in Figure 3 can be used as input for numerical analysis.

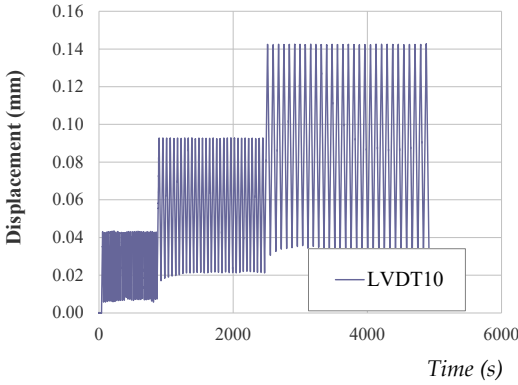
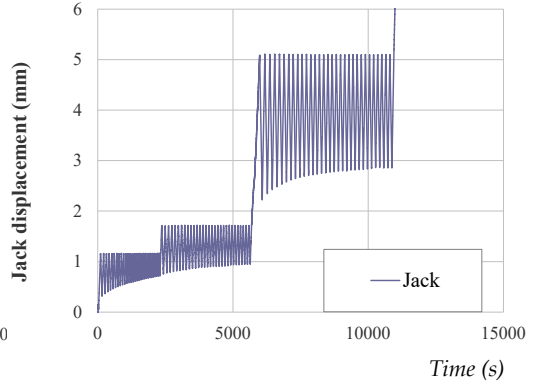
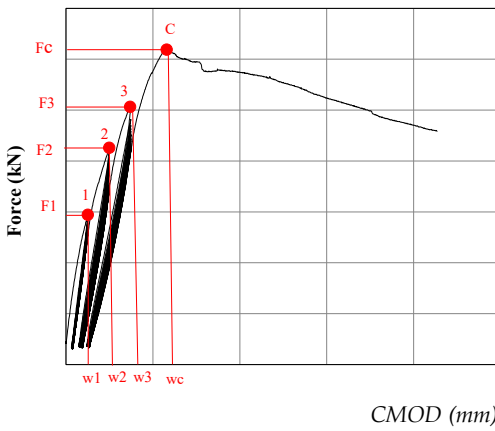
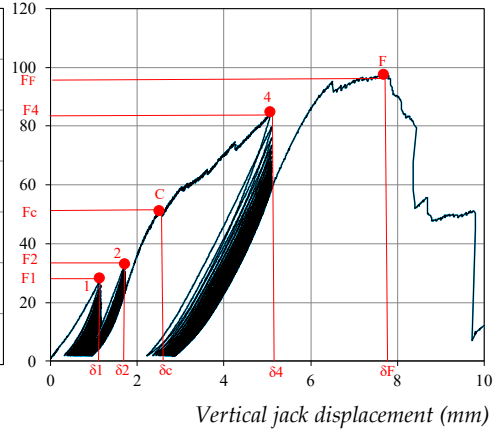
(a) Loading rate of unstrengthened specimens

(b) Loading rate of strengthened specimens

(c) Cyclic test of unstrengthened specimens

(d) Cyclic tests of strengthened specimens

Figure 7. Loading protocol

In the case of the unstrengthened wallets the test was performed by crack-mouth-opening control, while in the case of the strengthened wallets the vertical displacement of the jack was controlled. In the first case the crack mouth opening was chosen as controlling parameter in order to capture the quasi-brittle post-peak response; on the contrary in the second case this response was not observed allowing using the displacement control procedure. Both monotonic and cyclic tests were performed. The cyclic loading protocol consisted in three cycles composed of 30 runs (Figure 7) followed by a monotonic increase of the load up to failure. In the case of the unstrengthened wallets, the cycles were imposed at crack mouth opening (CMOD) equal to $w_1 = \frac{1}{4}w_c$, $w_2 = \frac{1}{2}w_c$ and $w_3 = \frac{3}{4}w_c$ of the crack mouth opening w_c corresponding to the peak force at point C (Figure 7a). In correspondence of point 1, 2 and 3 (Figure 7a) the ratio between the peak force F_i of each cycle and the maximum force F_c at point C (F_i / F_c) was found equal to 50%, 75% and 85%, respectively. Under monotonic loading, the strengthened specimen showed the transition between a flexural and a shear mechanism leading to the identification of two peak forces in the force versus displacement curve (point C and F). Considering this behaviour, the loading protocol was slightly modified by performing the first two cycles (C1 and C2) when the ratio between the applied force and the force at point C was equal to 50% and 75%, respectively, and the third cycle (C3) when the ratio between the applied force and the maximum force at point F was 85% (Figure 7b). Table 3 reports the loading scheme adopted for both unstrengthened and strengthened wallets.

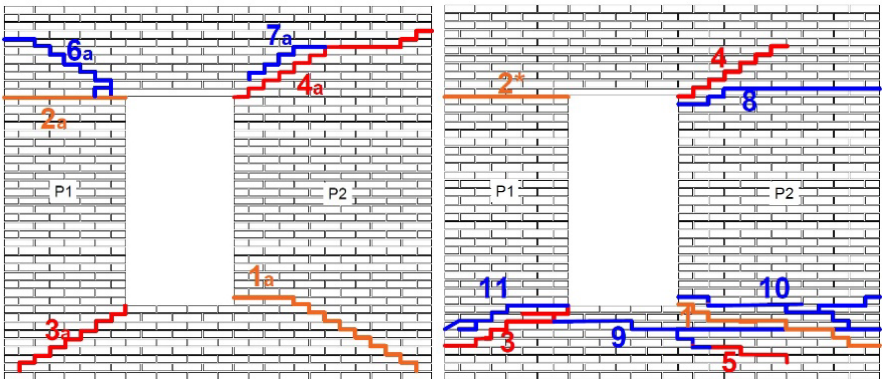
(a) Unstrengthened wall during the light damage phase 1 & 2

(c) Strengthened wall during the light damage phase 1 & 2

(e) Unstrengthened wall during the near collapse phase 3

(g) Strengthened wall during the near collapse phase 3

Figure 8a. Crack patterns

In this section, the results obtained from the in-plane test on the unstrengthened and strengthened walls are presented in terms of crack pattern and base shear force versus net horizontal displacement (Figure 8). The cracks are progressively numbered in order of occurrence.

The performance of the unstrengthened masonry is reported for wall TUD_COMP-45, which was re-tested in the light damage phase after strengthening and then tested up to near collapse. During Phase 1 (orange colour in Figure 8), the stepwise crack number 1 at the bottom-right corner of the window opening re-opened; while at the top-left corner, crack number 2* occurred horizontally in a mortar joint where the reinforcement was not present. During phase 2 (red colour in Figure 8), crack number 3 and 4 re-opened and propagated diagonally from the bottom-left corner and top-right corner of the window opening, respectively. In phase 3 up to the same displacement at which the test for the

unstrengthened wall was stopped (C18, $d = 53.77/-53.80$ mm), a crack pattern composed of cracks starting at the window opening was observed, similarly to the unstrengthened wall. The following minor differences with the unstrengthened wall TUD_COMP-41 can be listed: stepwise cracks number 6a and 7a did not occur and an additional horizontal crack (number 8) was present on the wide pier P2. During cycle C18 ($d = 53.77/-53.80$ mm) horizontal cracks below the window opening occurred, probably caused by the formation of an arching mechanism induced by the reinforcement. The first sign of toe crushing consisting of vertical cracks in the bricks started during cycle C18 ($d = 53.77/-53.80$ mm) at the bottom-left and during cycle C19 ($d = 67.26/-67.28$ mm) at the bottom-right corner.

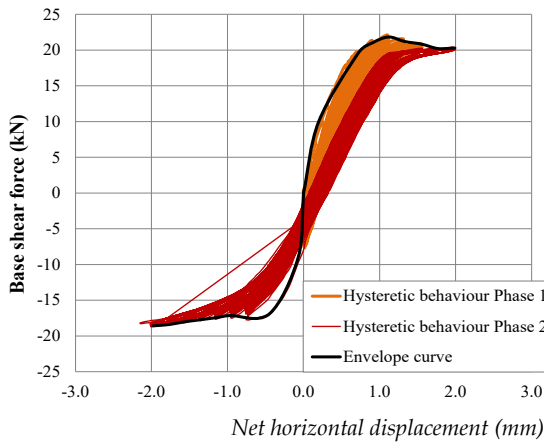
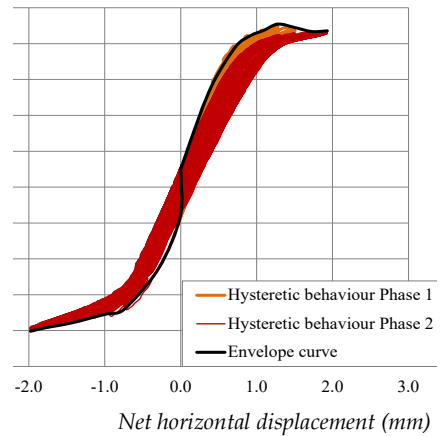
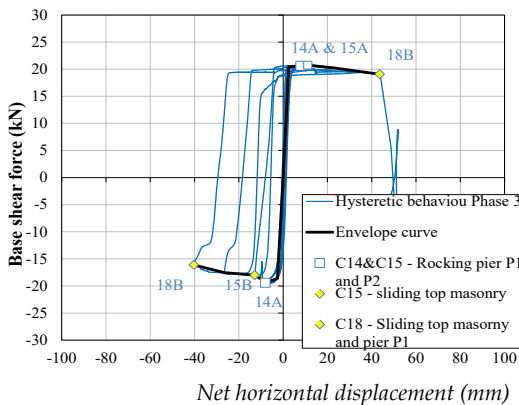
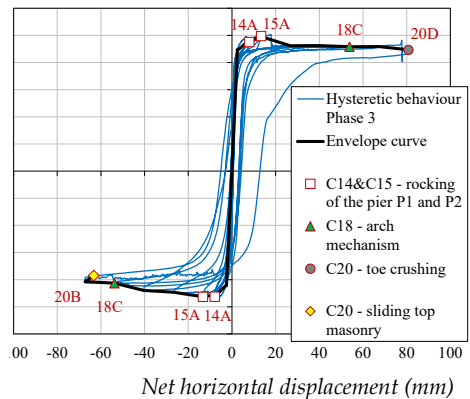
(b) Unstrengthened wall during the light damage phase 1 & 2

(d) Strengthened wall during the light damage phase 1 & 2

(f) Unstrengthened wall during the near collapse phase 3

(h) Strengthened wall during the near collapse phase 3

Figure 8b. Base shear force versus net horizontal displacement curve

The performance of the unstrengthened masonry is reported for wall TUD_COMP-45 (Korswagen et al. 2017, Korswagen et al. 2018) in the light damage phase and for wall TUD_COMP-41 (Korswagen et al. 2017, Korswagen et al. 2018, Messali 2018) in the near collapse phase. Both walls showed a similar behaviour in the light damage phase except for minor differences in the crack patterns that are highlighted by introducing the subscript “a” to the crack number for wall TUD_COMP-41. During Phase 1 (orange colour in Figure 8) crack number 1 and 2 developed diagonally from the bottom-right and the top-left opening’s corner, respectively. During Phase 2 (red colour in Figure 8) crack number 3 and 4 propagated with a stepwise configuration from the bottom-left and the top-right corner of the window opening, respectively. During Phase 3 (blue colour in Figure 8), existing cracks further developed by increasing their width and length. At the end of phase 3 the cracks were mainly diagonal with a stepwise shape, starting from the window corner. Considering the first cycle of phase 1 ($C1 d = 0.72$ mm), the elastic stiffness was calculated as 29.06 kN/mm and 26.88 kN/mm for wall TUD_COMP-45 and TUD_COMP-41, respectively. The maximum base shear force of wall TUD_COMP-41 was equal to 22.05 kN ($C4 d = 1.30$ mm) and to -19.54 kN ($C14 d = -7.97$ mm) for the positive and negative loading direction, respectively. For wall TUD_COMP-41, the ultimate displacement was equal to approximately 40 mm in both loading directions, corresponding to a drift of 1.61/-1.49 %.

Eventually, the test was stopped because excessive out-of-plane deformations were recorded. The strengthened wall showed an initial stiffness equal to 28.78 kN/mm (evaluated in C1 $d = 0.73$ mm) and a maximum base shear force was equal to 25.14 kN (C16 $d = 23.08$ mm) and -23.46 kN (C14 $d = -7.90$ mm) for the positive and negative loading direction, respectively. At the end of the near collapse phase, the ultimate displacement was equal approximately to 80 mm and to -60 mm for the positive and negative loading direction, corresponding to an ultimate drift of 2.99/-2.34 %.

crushing at the bottom of the wall. Considering the unstrengthened wall, until cycle C14 ($d = 7.89/-7.97$ mm) the rocking of the piers was the prevailing mechanisms in both loading directions (point 14-A, Figure 8f). During cycle C15 ($d = -12.82$ mm) sliding of the top masonry portion occurred with respect to both piers in the negative loading direction (point 15-B, Figure 8f), while rocking of the piers was the prevailing mechanism for the positive loading direction. During cycle C18 ($d = 43.63$ mm) for positive loading (point 18-B, Figure 8f), the L-shaped portion of masonry composed of the top part of the wall and pier P2 started to slide with respect to the remaining parts of the wall. This led to the loss of integrity of the wall and to the consequent termination of the test. Initially, the strengthened wall showed a behaviour similar to the unstrengthened one with rocking of the piers in both loading directions (points 14-A and 15-A, Figure 8h). During cycle C18 ($d = 53.77/-53.80$ mm) horizontal cracks occurred in the masonry portion below the window opening and a small uplift of the central bricks was observed. This suggests the formation of an arch mechanism caused by the activation of the twisted steel bars embedded in the bed joints (point 18-C, Figure 8h). Thanks to the ability of the bed joint reinforcement to keep the integrity of the wall, larger net horizontal displacement could be attained for the strengthened wall with respect to the unstrengthened one. During cycle 20 ($d = 80.96/-63.31$ mm) toe crushing (Figure 12a) of the bottom right corner (point 20-D, Figure 8h) and sliding of the top masonry portion with respect to the piers (point 20-B, Figure 8h) occurred in positive and negative loading direction, respectively.

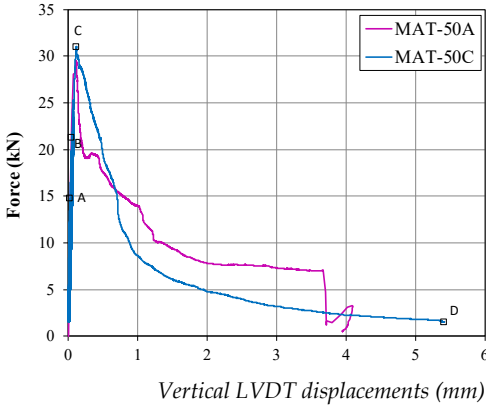
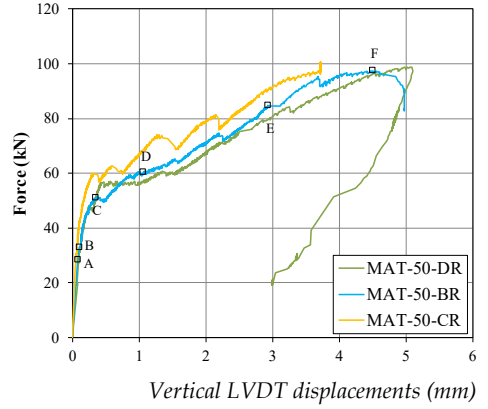
(a) Unstrengthened specimens

(b) Strengthened specimens

(c) Unstrengthened specimens

(d) Strengthened specimens

Figure 9. Force-displacement curve and crack pattern evolution observed during window bank tests

Figure 9 shows the force versus the vertical displacement calculated considering the reading of LVDTs and the crack pattern evolution obtained through the DIC analysis. The envelope curves are reported and were calculated by considering the peak force in correspondence of each cycle. Relevant loads level were as follows: point A corresponds to the onset of cracking, point B corresponds to a force equal to $70 \pm 75\%$ of the force at point C, point C is defined as the peak force with flexure mechanism, point D refers to the failure for the unstrengthened specimen and to the transition to a shear mechanism for the strengthened wallets, point E corresponds to a force equal to 85% of the force at point F, and point F corresponds to the maximum force for the strengthened wallets obtained with a shear failure. In Figure 9, the comparison in terms of crack pattern is made by considering points A, C, D and F.

Considering the unstrengthened wallets, the force-displacement curve shows a linear behaviour up to the peak followed by an exponential softening curve; a flexural failure mechanism was observed. The first crack (point A) occurred in the head joints at the top of the masonry wallet and in the first bed joint at the bottom. Afterwards cracks in head and bed joints between the supports (in the constant moment zone) occurred leading to a flexural type failure. A maximum crack width of approximately 0.05 and 6.96 mm was observed at the peak force (point C) and at the end of the test (point D), respectively.

The strengthened wallets showed a transition from flexural to shear mechanism. Similarly to the unstrengthened wallets, at onset of cracking (point A) the first crack appeared in vertical head joints at the top of the specimen and in the last mortar bed joint at the bottom of the specimen. Afterwards the presence of small cracks in the joints located at the centre of the wallets lead to a slight reduction in stiffness up to point C, followed by a plateau up to point D. From point D cracks arose both in the joints and in the bricks forming diagonal shear-type cracks that lead to a substantial decrease in stiffness of the specimen up to the maximum force attained at point F. After point F a post-peak behaviour was recorded.

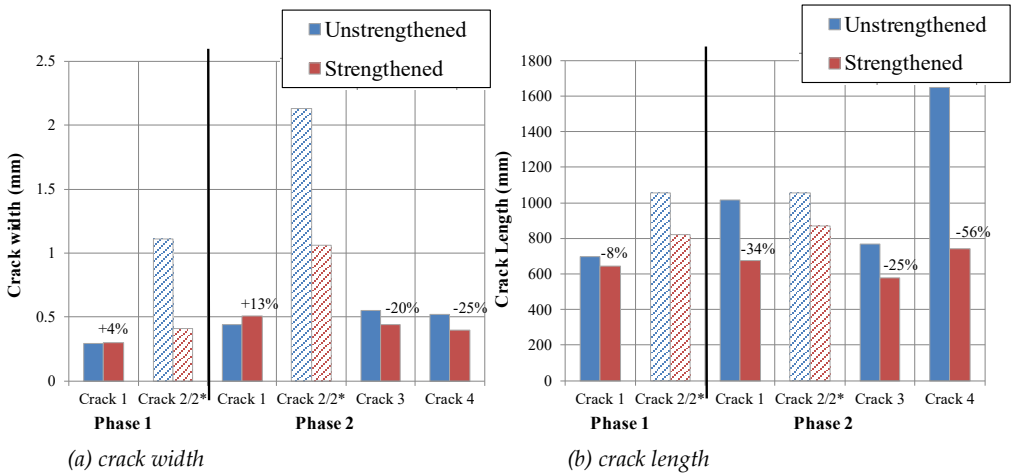
Figure 10. Performance during light damage phase test in terms of crack with and crack length

At the end of the light damage phase (phase 2), the strengthened wall showed a reduction in (maximum) crack width between 20 and 25% and in crack length between 25 and 56% (Figure 10). These values were determined for cracks occurring at the same location and having similar shape. Consequently, the horizontal crack number 2* of the strengthened wall is not comparable with the stepwise crack number 2 of the unstrengthened wall, because this will result in misleading higher value of crack width. For both the unstrengthened and strengthened wall, the onset of cracking occurred at the same net horizontal displacement ($C1, d = 0.73$ mm).

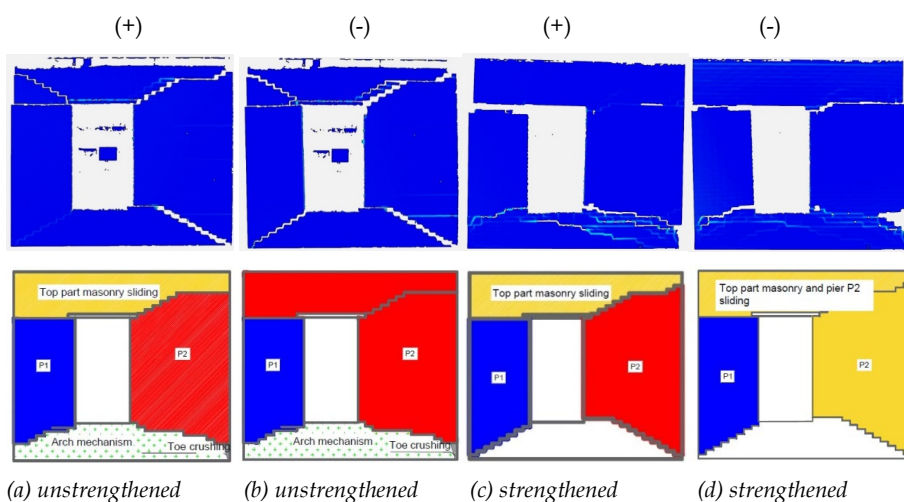
(a) unstrengthened (b) unstrengthened (c) strengthened (d) strengthened
 Figure 11. Relevant failure mechanism observed through DIC analysis at the end of the near collapse phase (phase 3)

Figure 11 shows the failure mechanisms of the masonry components during the near collapse phase (phase 3) for both unstrengthened and strengthened wall. Load levels associated to relevant mechanisms are marked in Figure 8, where point A refers to rocking of one of the piers, point B indicates sliding between two parts of the wall, point C refers to the formation of an arch mechanism below the window opening and point D indicates toe

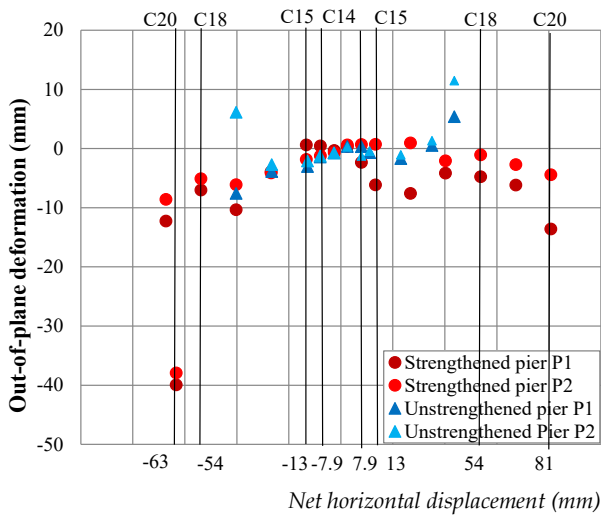
Figure 13. Out-of-plane deformation

Differently than for the unstrengthened wall, the strengthened wall showed excessive out-of-plane deformation of the piers (Figure 12b), which lead to the termination of the test. Figure 13 shows the out-of-plane deformation versus the net horizontal displacement for the unstrengthened (blue triangles) and strengthened wall (red circles). The unstrengthened wall was subjected to an out-of-plane deformation of 10 mm in the last cycle (cycle C18). Considering the strengthened wall, the out-of-plane deformation was similar to the one observed for the unstrengthened wall up to cycle C15, especially for the narrow pier P1. In correspondence of the last cycle (C20, $d = -63$ mm) both piers showed a significant out-of-plane deformation of approximately 40 mm for the negative loading direction. This out-of-plane deformation can be attributed to the asymmetric position of the twisted steel bars in the thickness of the wall (Figure 1b) and to the difference in stiffness between the repair and the construction mortar.

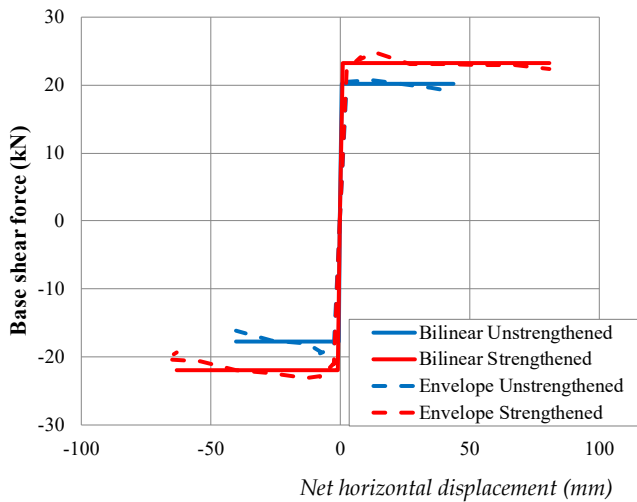
Figure 14. equivalent bilinear curve

To compare the seismic performance of the unstrengthened and strengthened wall, the equivalent bilinear curve was calculated (Magenes et al. 2008, Morandi et al. 2018) (Figure 14). The strengthened wall showed a slight increment in force capacity (+15%) and a significant increment in terms of displacement capacity (+40 ÷ 45%) and ductility (+30 ÷ 40%). Both walls show a limited reduction in force capacity after reaching its maximum value; this is consistent with the rocking or sliding failure mechanism observed in both walls.
